HouseProbe Inspections

18 Marshall Street , Petersburg , VA 23803
Inspection prepared for: Linwood James & Kimberly James
Date of Inspection: 6/12/2021 Time: 4:30
Age of Home: 166 Size: 2675
Weather: Overcast

Inspector: Chris DiRienzo
License #3380001285
11309 courthouse Road, Dinwiddie, VA 23841
Phone: 804-731-9061
Email: HouseProbe@gmail.com
www.housprobe.com

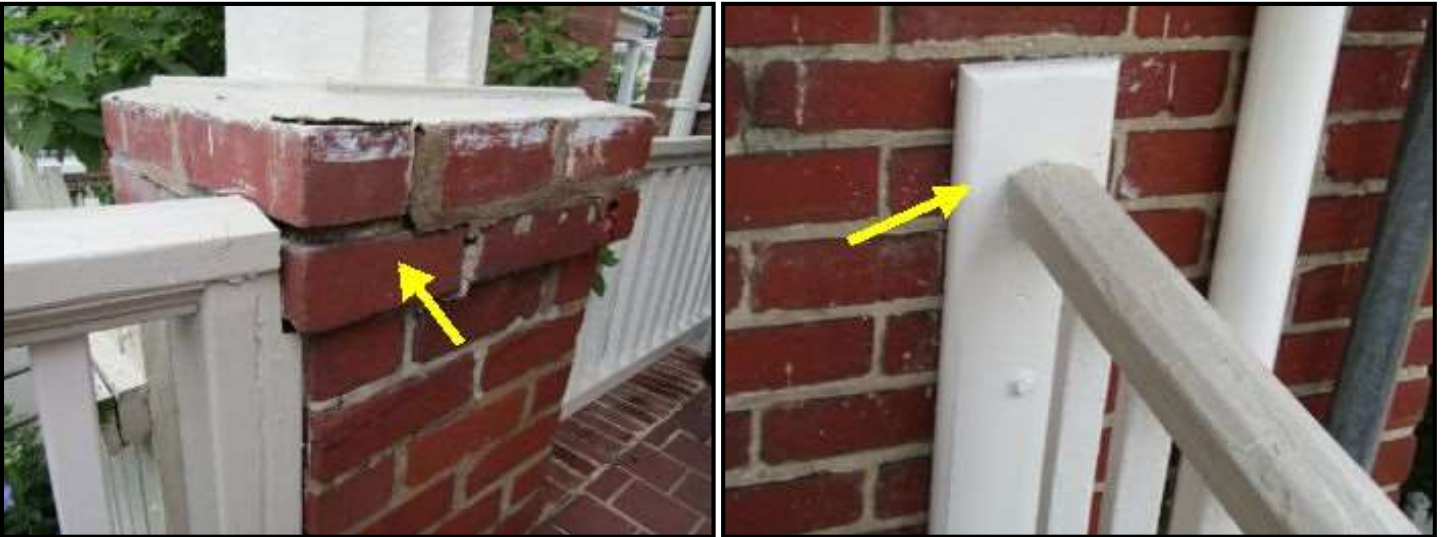
• There are loose bricks and mortar deterioration at the rear porch post. Recommend repair by a licensed contractor.

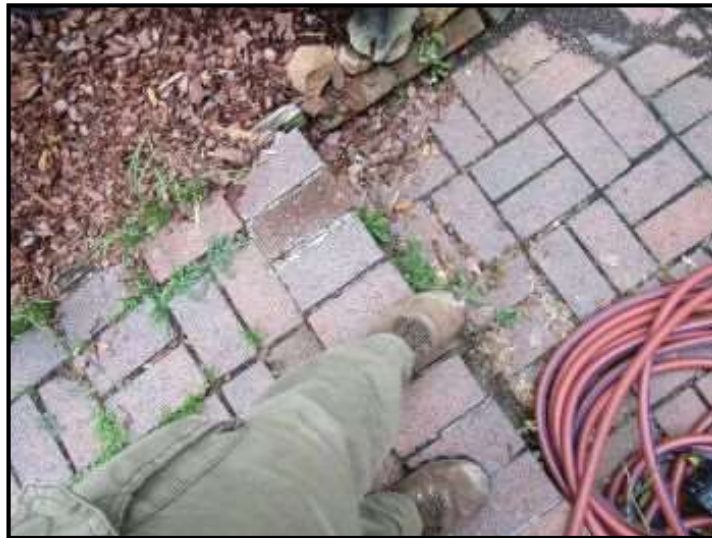
• **There is a trip hazard at the rear walkway. Recommend repair by a licensed contractor.**

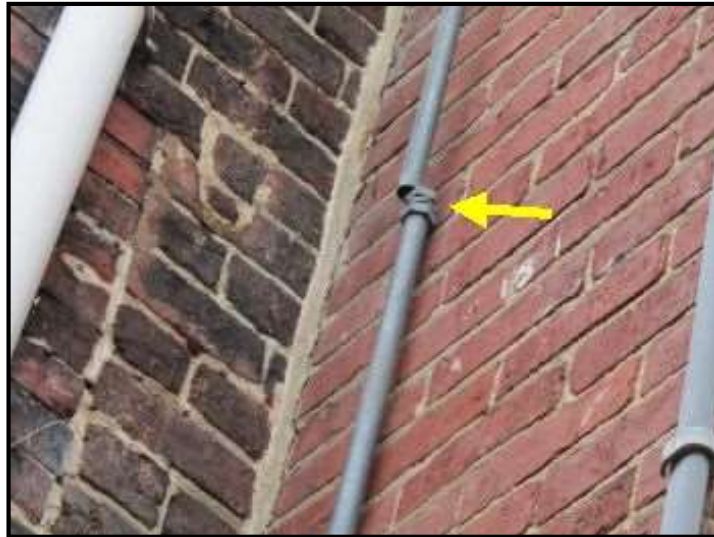
• **There is loose conduit at the electrical outside the home. Recommend repair by a licensed electrical contractor.**

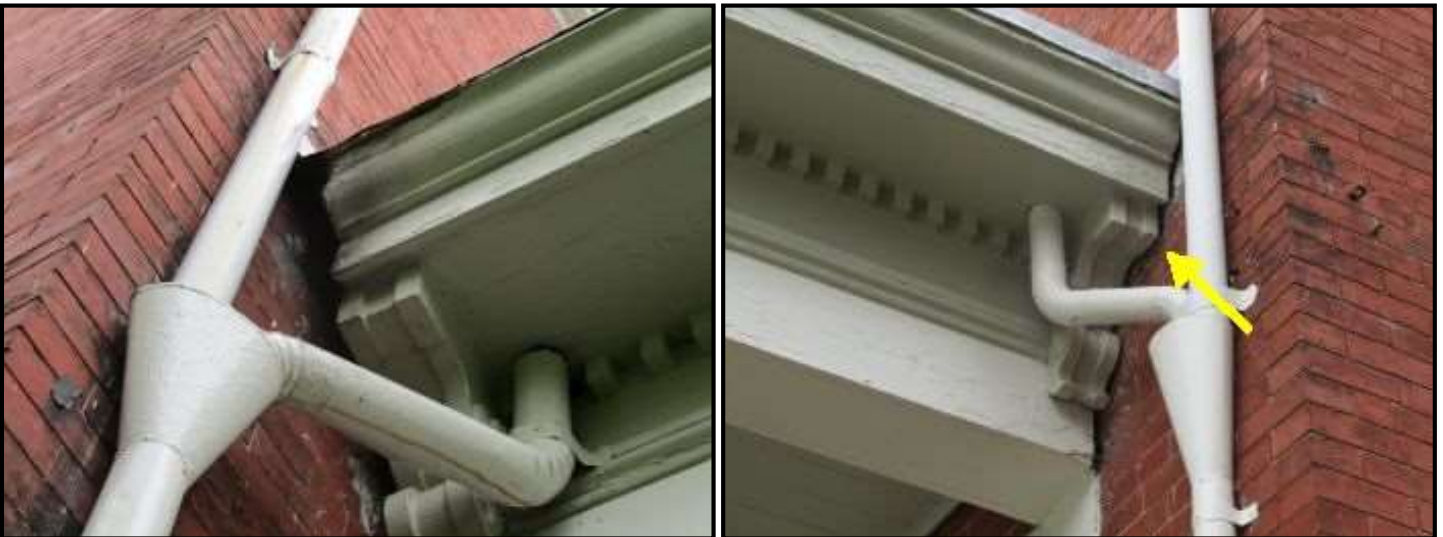
• **It appears the front porch roof has pulled away from the house a good 4 to 5 inches and approximately 1 to 2 inches on the right side of the front porch roof. Recommend repair by a licensed contractor.
1,500.00 - 2,500.00**

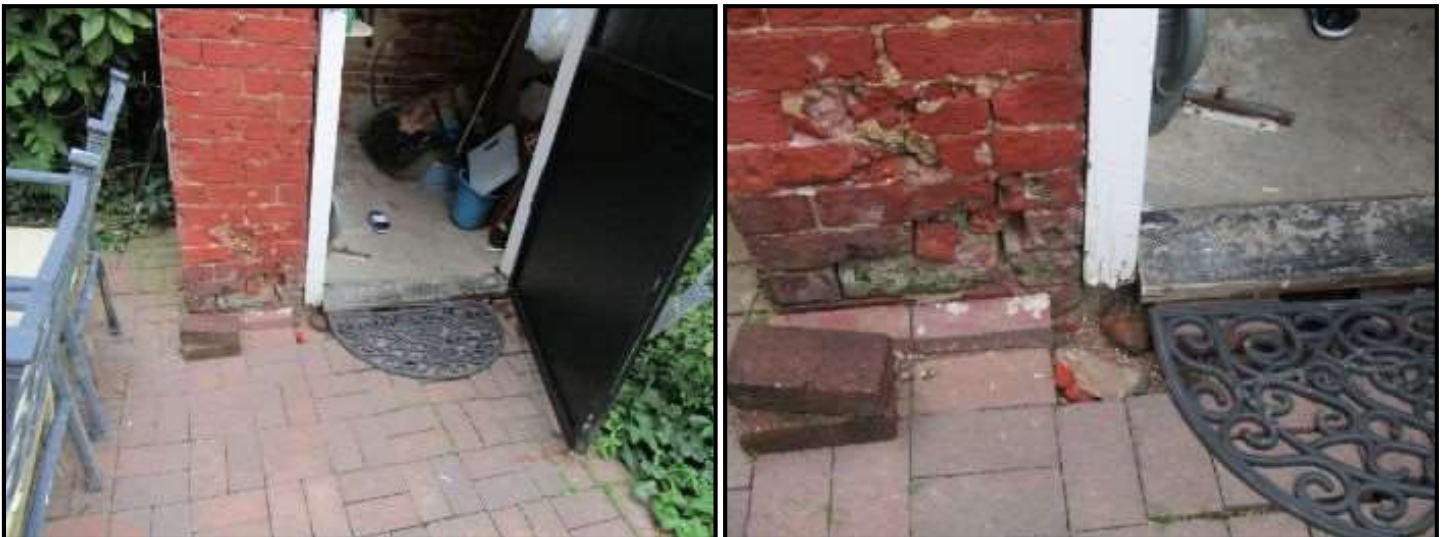
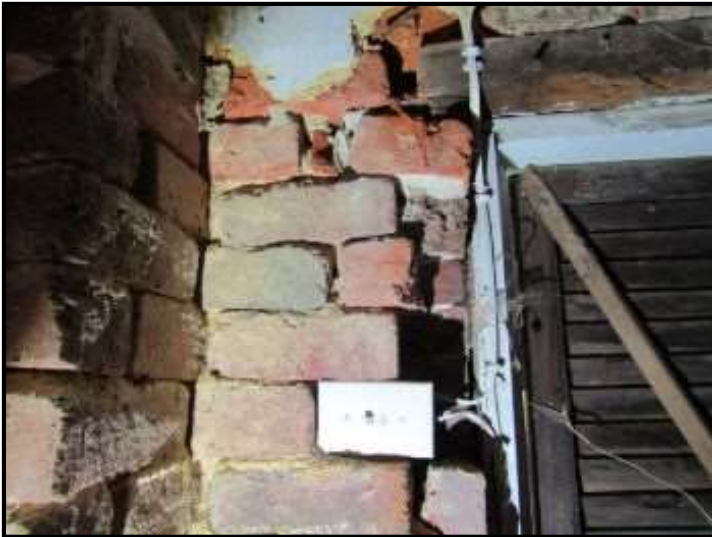
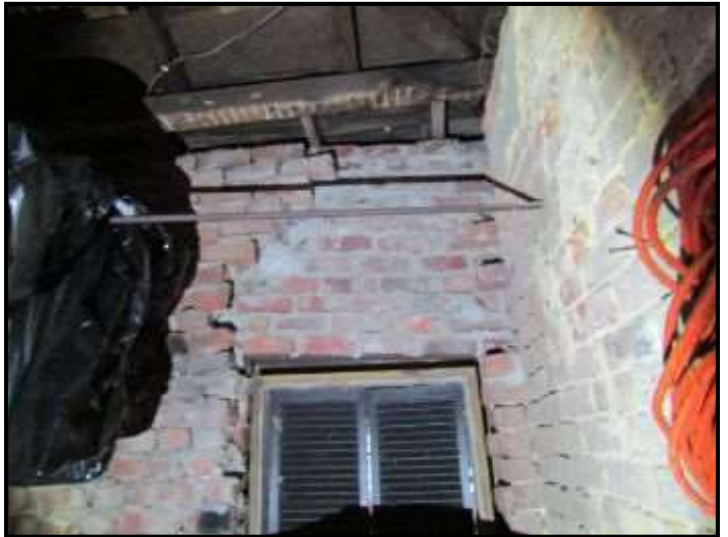
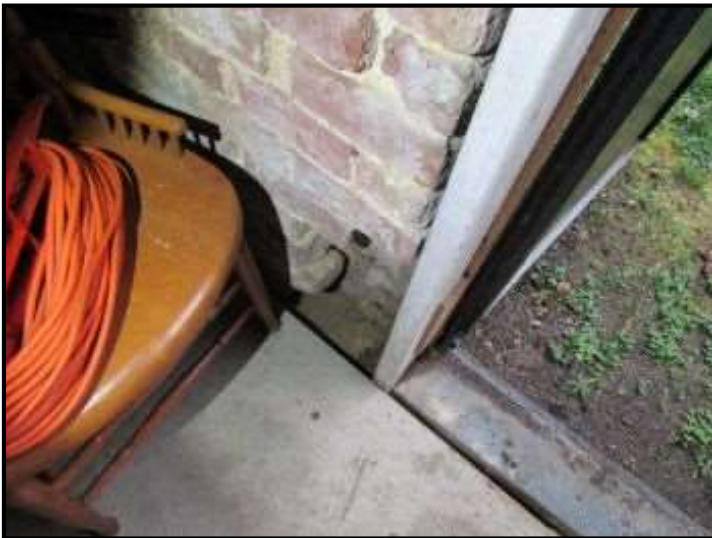
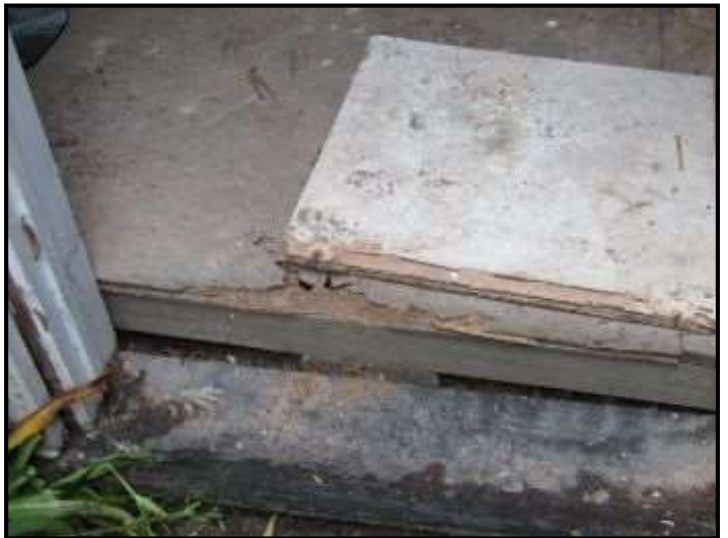
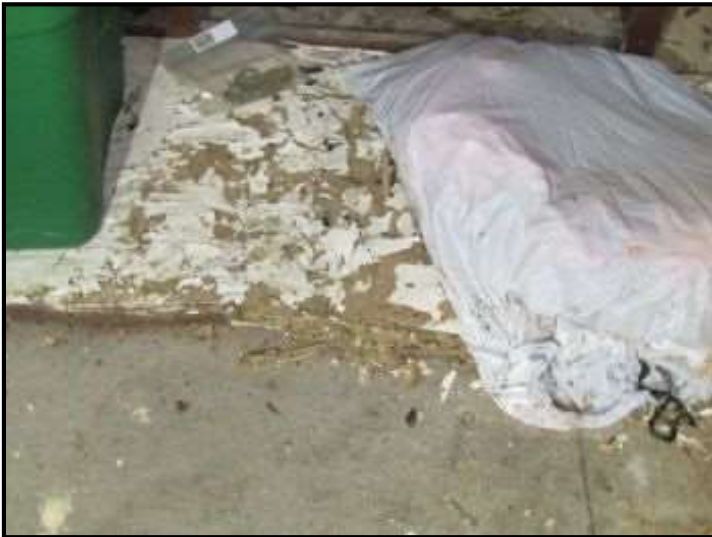
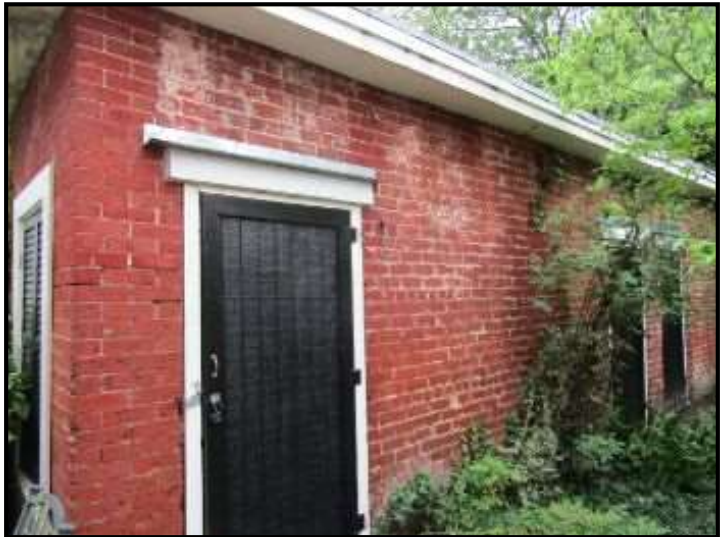
- **The shed is in serviceable condition. Some wood flooring, brick wall deterioration and wood destroying insects noted. Sheds are typically sold as is.**

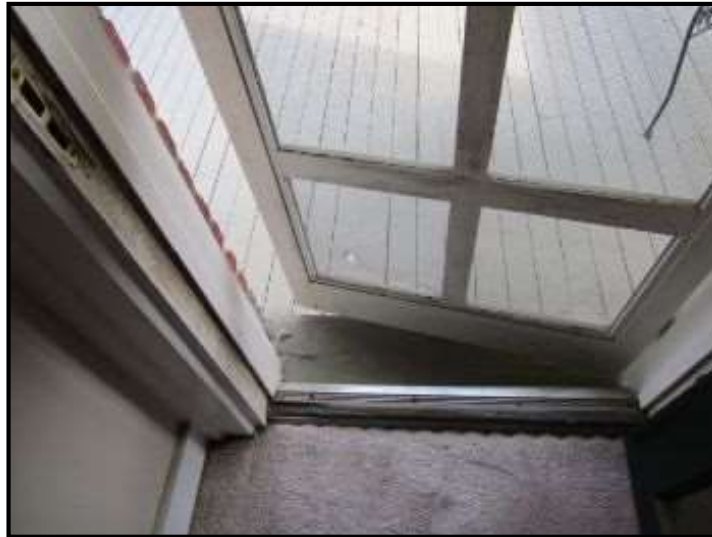
- The rear storm door sticks in the frame. Recommend repair by a licensed contractor.
75.00 - 100.00

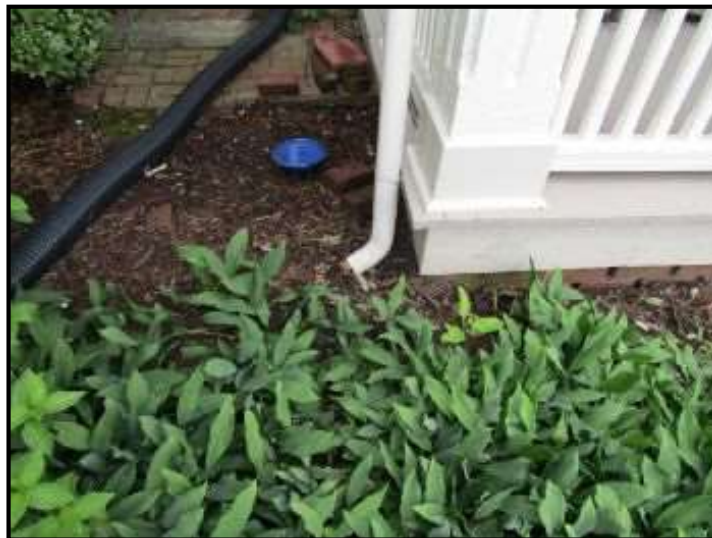
• One or more downspouts have no extensions, or have extensions that are ineffective. This can result in water accumulating around the structure's foundation, or in basements and crawl spaces if they exist. Accumulated water is a conducive condition to wood destroying insects and organisms, and may also cause the foundation to settle and possibly fail over time. Recommend making repairs as necessary such as repairing or installing splash blocks or tie-ins to underground drain lines so rain water is carried at least several feet away from the structure to soil that slopes down and away from the structure.

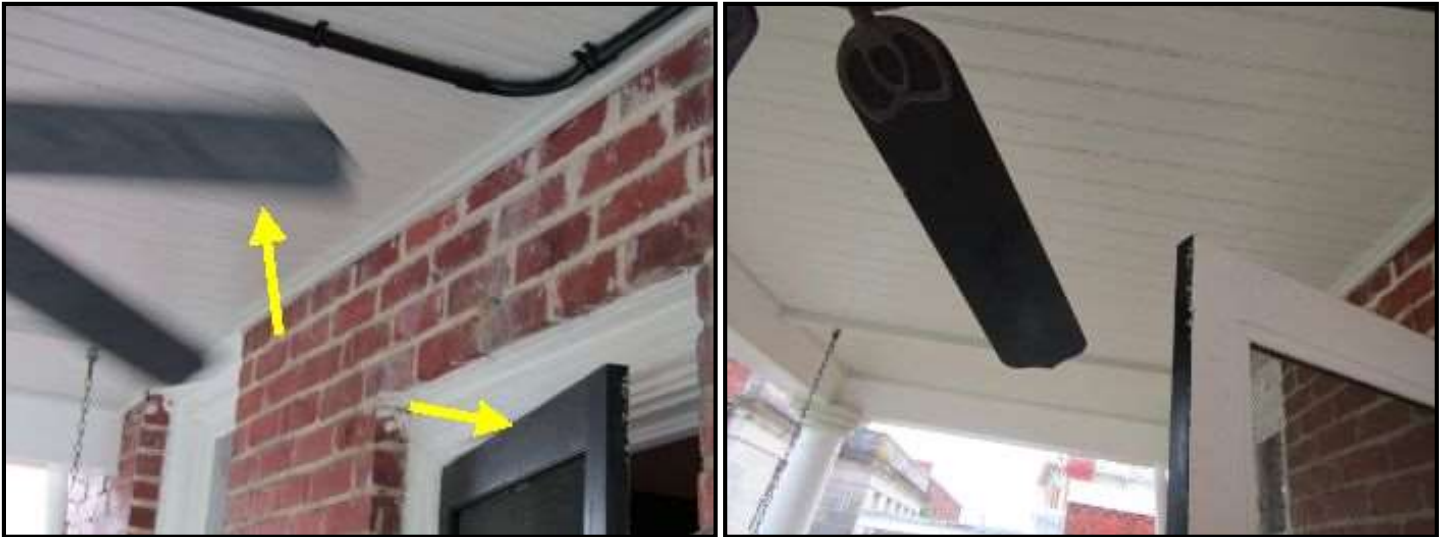
• The rear ceiling fan wobbles and one blade is low and hits the screen door when opened. Recommend repair by a licensed contractor.
150.00 - 250.00

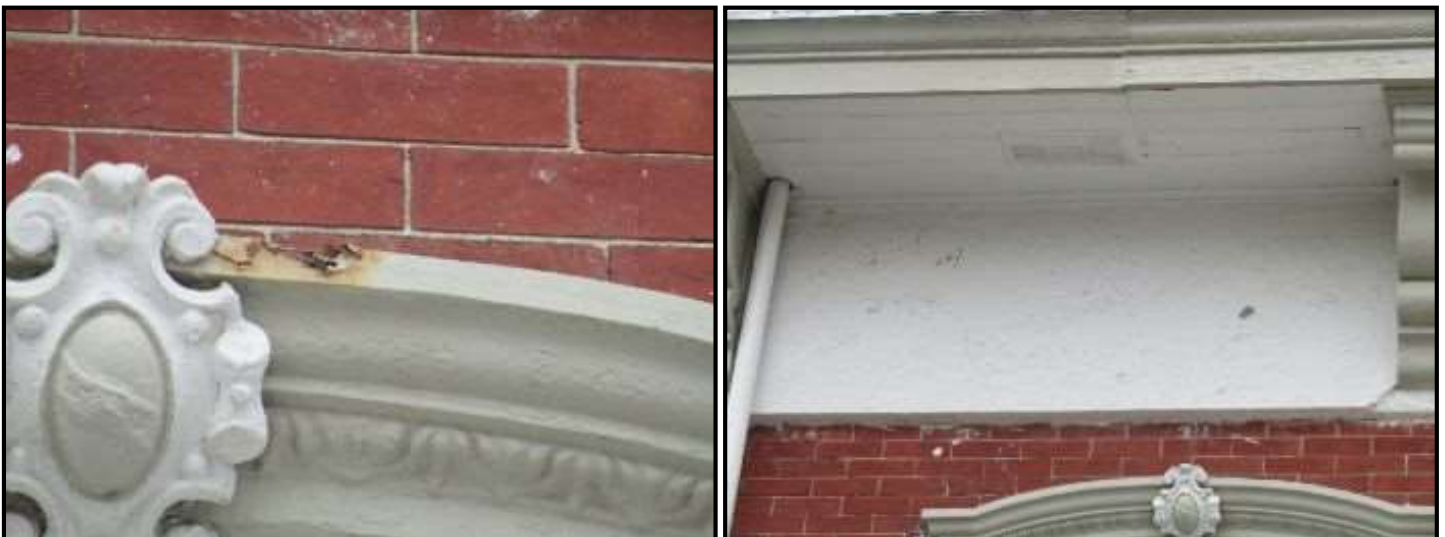
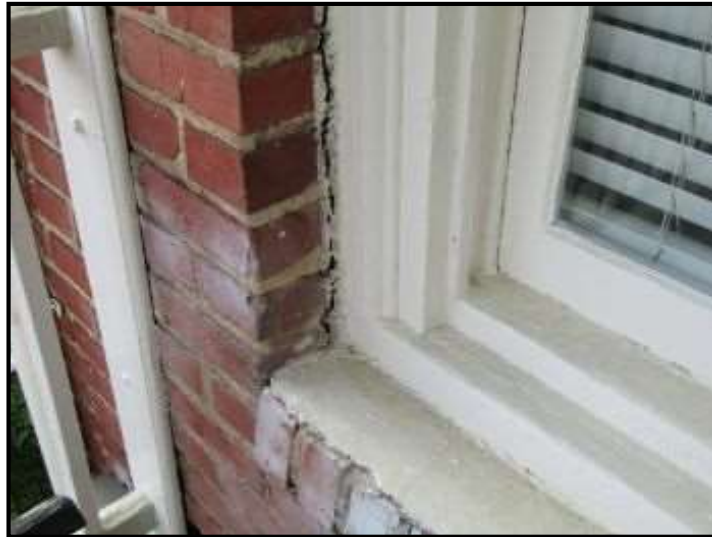
- Suggest sealing/caulking as part of routine maintenance to prevent deterioration.
- Approximately 3/4 of the homes built before 1978 (about 64 million homes) contain some lead-based paint. For more information, refer to the following EPA Fact Sheet:
<http://www.hud.gov/offices/lead/library/enforcement/fs-discl.pdf>
- There is paint and caulking deterioration at the soffit and trim. Recommend repair by licensed painting contractor.
1,000.00 - 2,000.00

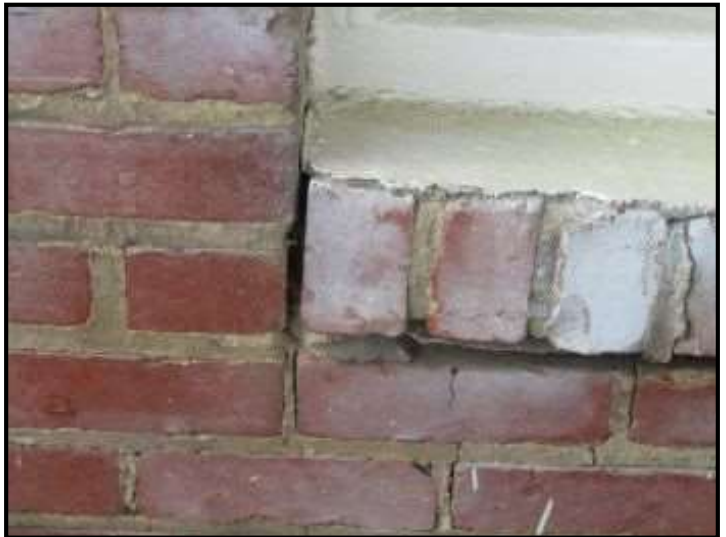
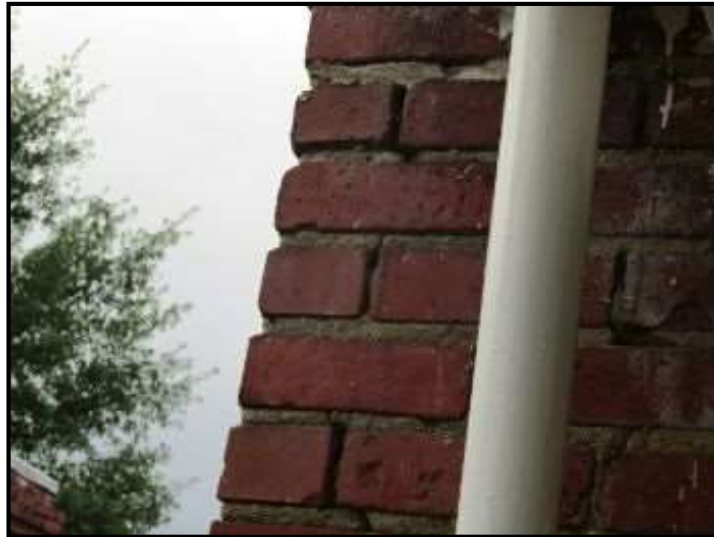
- **Caulk and seal all gaps, cracks and openings.**
- **There is mortar deterioration, large gaps and deterioration at the exterior siding of the home. Recommend repair by a licensed contractor.**
1,500.00 - 2,500.00

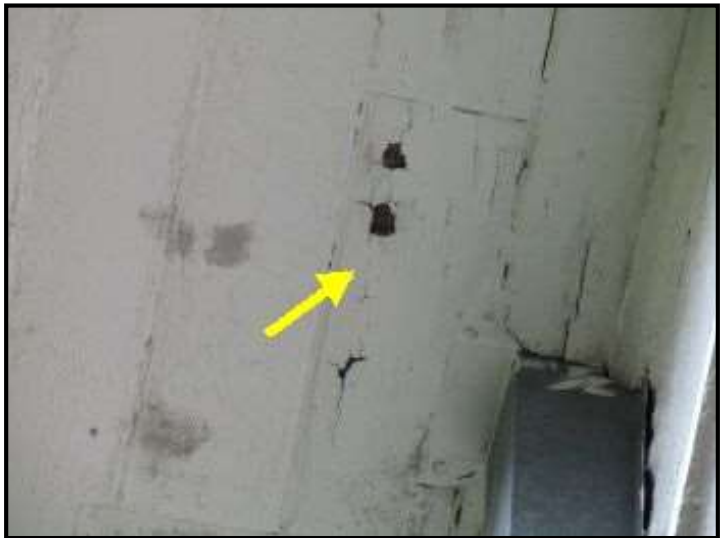
- **There is wood trim deterioration at the soffit and trim. Recommend repair by a licensed contractor. 1,000.00 - 2,000.00**

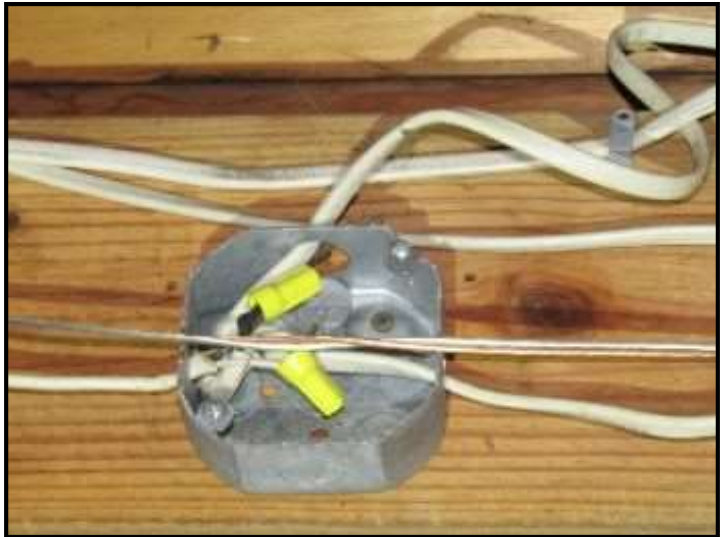
- **No GFCI protection in the detached garage. Recommend upgrading.**
- **Exposed electrical wiring not contained in covered junction boxes. This is a safety hazard. Recommend repair by a licensed electrical contractor.**
200.00 - 300.00

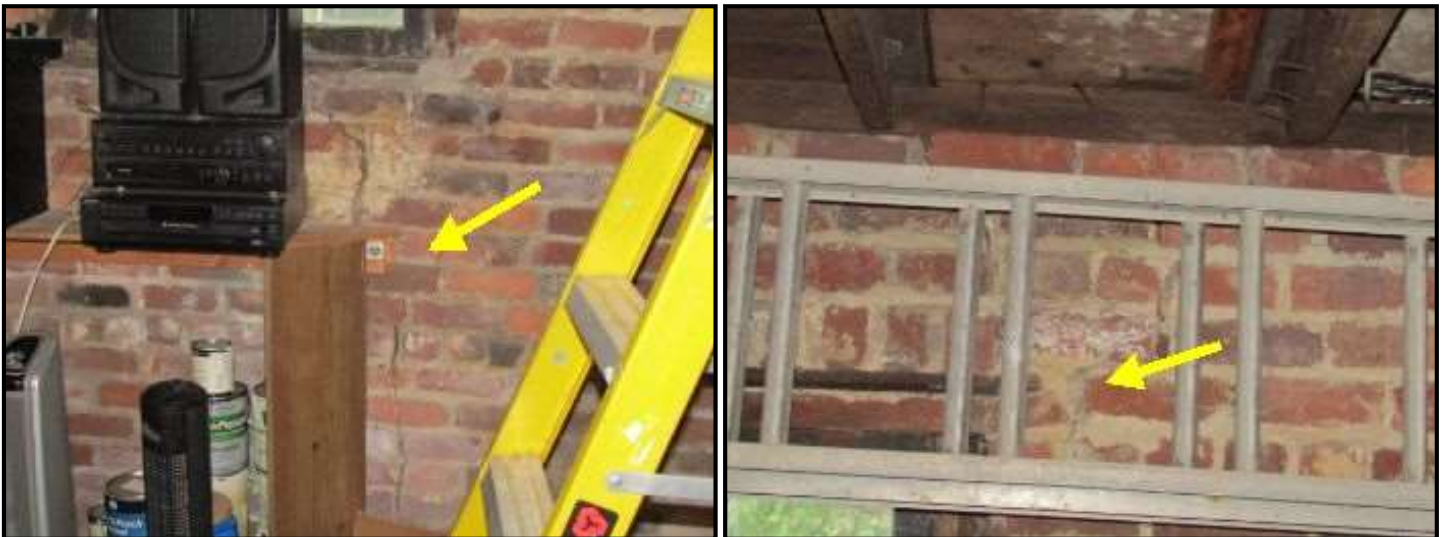
• Major cracks (more than 3/4" wide) were found in the foundation. The client is strongly advised to have a qualified geotechnical and/or qualified structural engineer evaluate this property to determine the likelihood of future settlement and/or soil movement, and to determine the integrity of the structure. Significant repairs may be necessary.

Foundation cracks should also be sealed to prevent water infiltration.

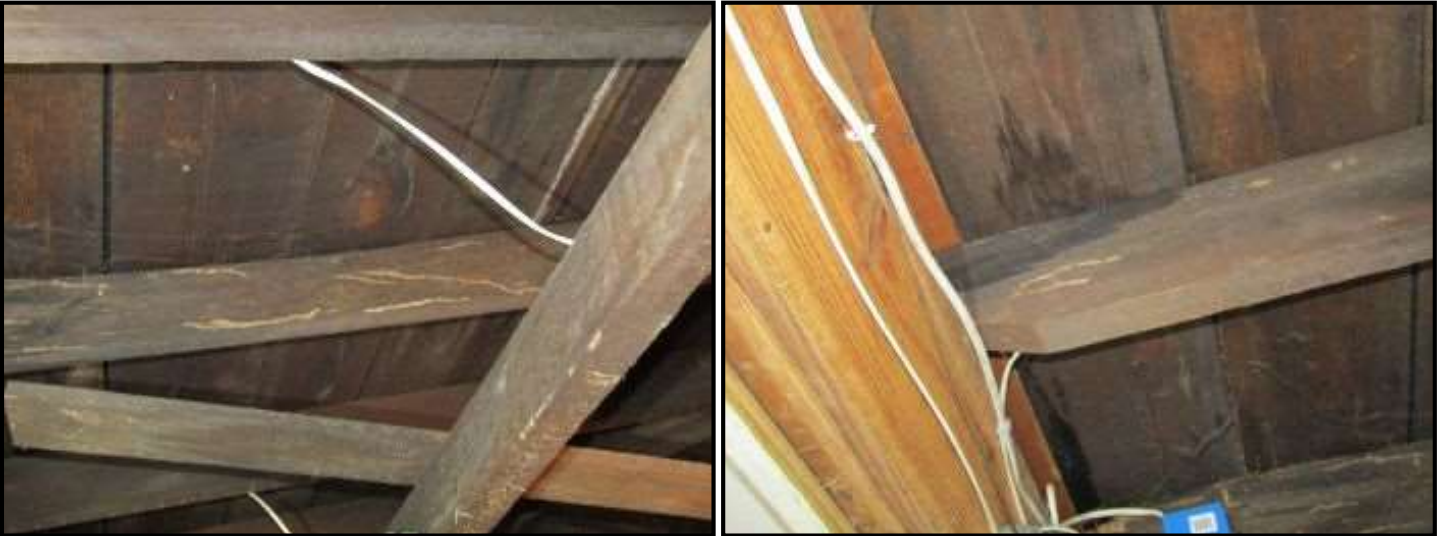
- Evidence of wood destroying insects noted. Recommend evaluation by a licensed pest control contractor.

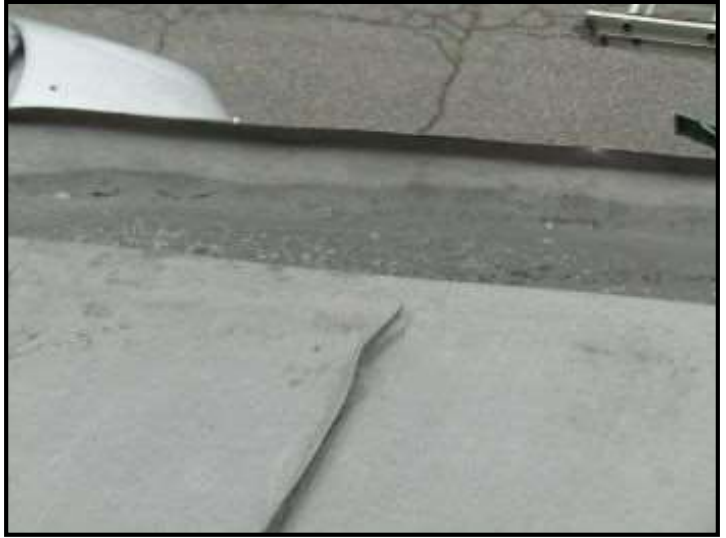
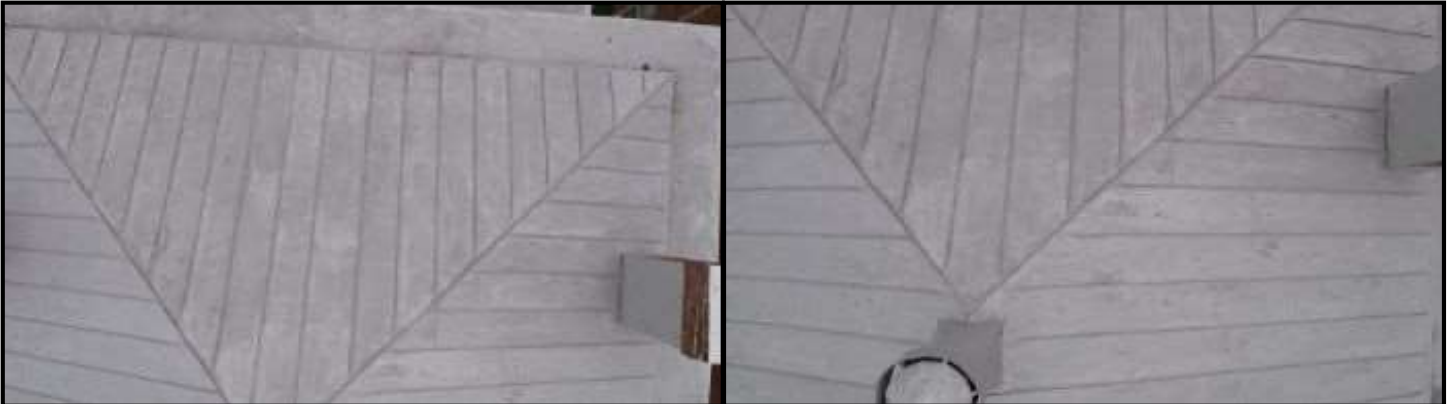
- The roof structure appears to be in serviceable condition with normal wear. However, the paint and sealing is deteriorated and the roof flashing is pulling away at the porch roof. This a metal roof and it will require maintenance of spot painting and sealing.
2,000.00 - 3,000.00

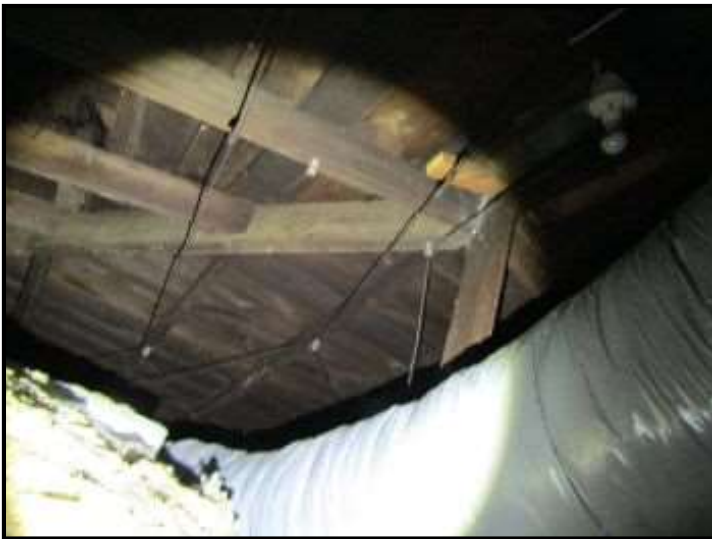
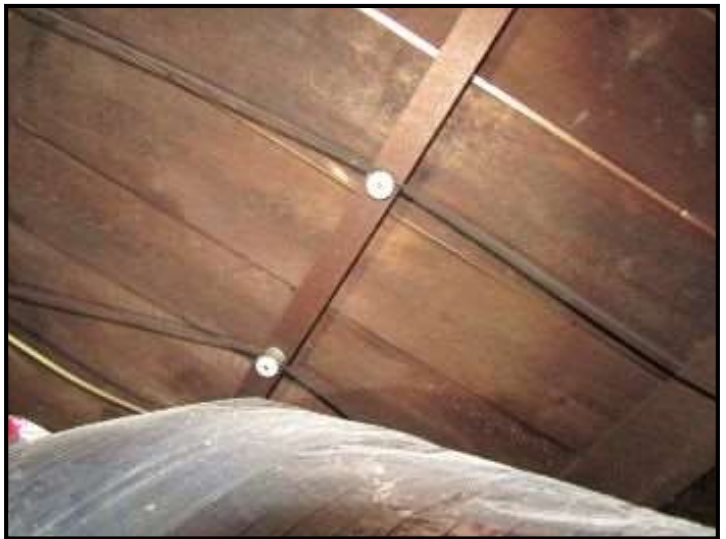
- **Live knob and tube wiring present(K&T). This is an obsolete system and a safety and fire hazard. Due to insulation covering wires and any modifications to the wiring. There is no ground wire and cannot service three-pronged appliances. Some home insurance companies will not insure homes with K&T. Recommend evaluation of K&T and ensure to be in serviceable condition. 1,250.00 - 1,350.00 or Quote**

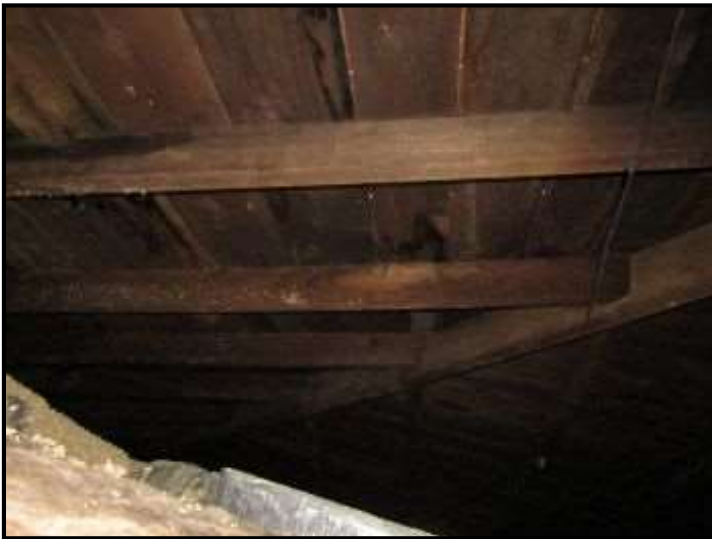
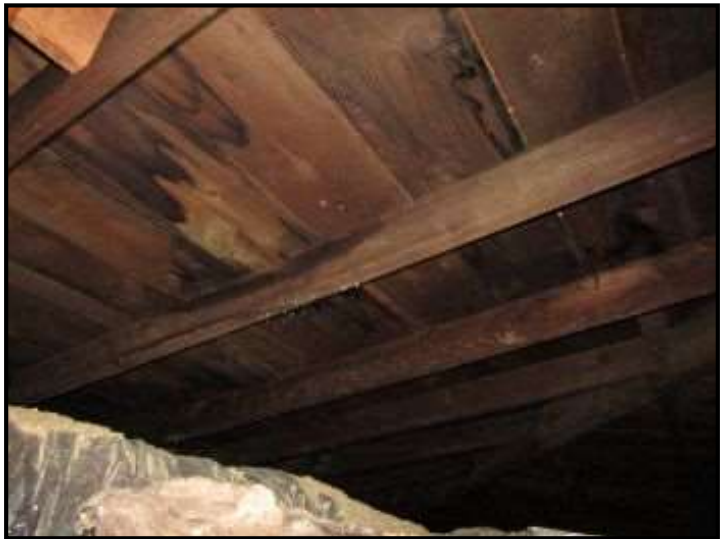
- There is evidence of past moisture intrusion in the attic. The areas were dry at the time of the inspection.

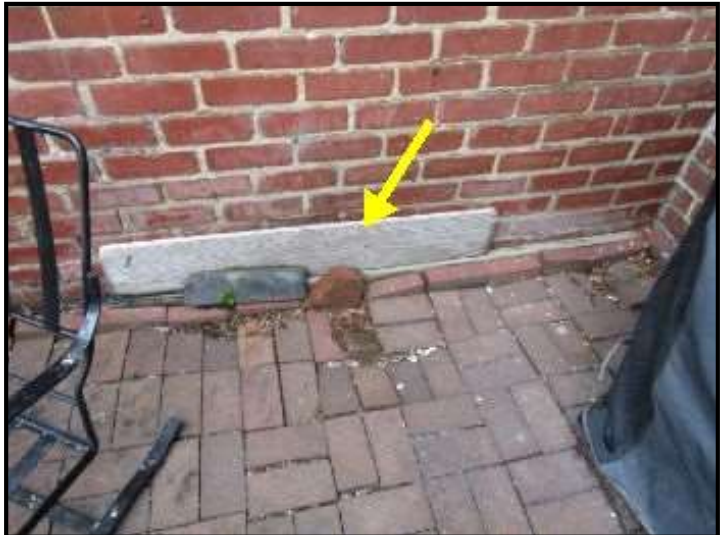
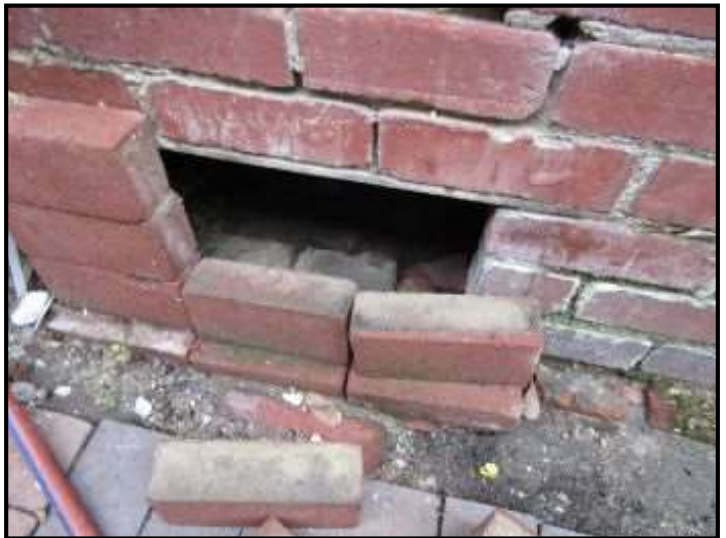
- **There are holes in the foundation large enough for rodent intrusion. Recommend filling or closing any holes with mortar or grout.**
 - **Cracks / Holes present in: foundation / floor / ext. wall. Recommend filling repair and sealing them to prevent water infiltration.**
- 1,000.00 - 2,000.00**

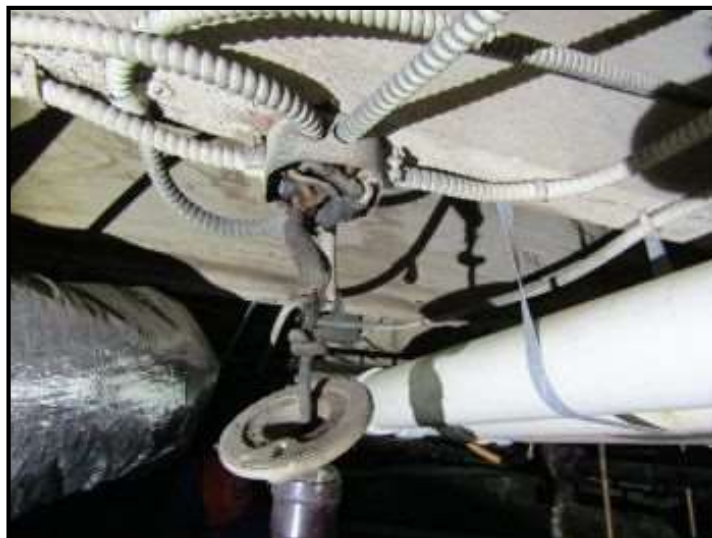
- One or more sections of loose, unterminated, non-metallic sheathed (Romex) wiring were found. Recommend having a qualified, licensed electrician evaluate and repair as necessary. This may require cutting the wire to length and terminating the wire with wire nuts in a securely anchored and covered junction box.

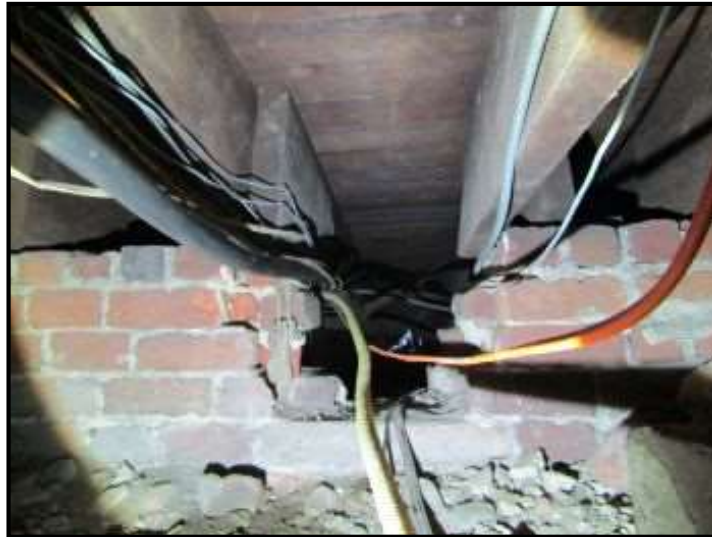
- No insulation under floor in crawl space. Recommend installing R19 or better (6" thick fiberglass batt) insulation below floor for energy efficiency.

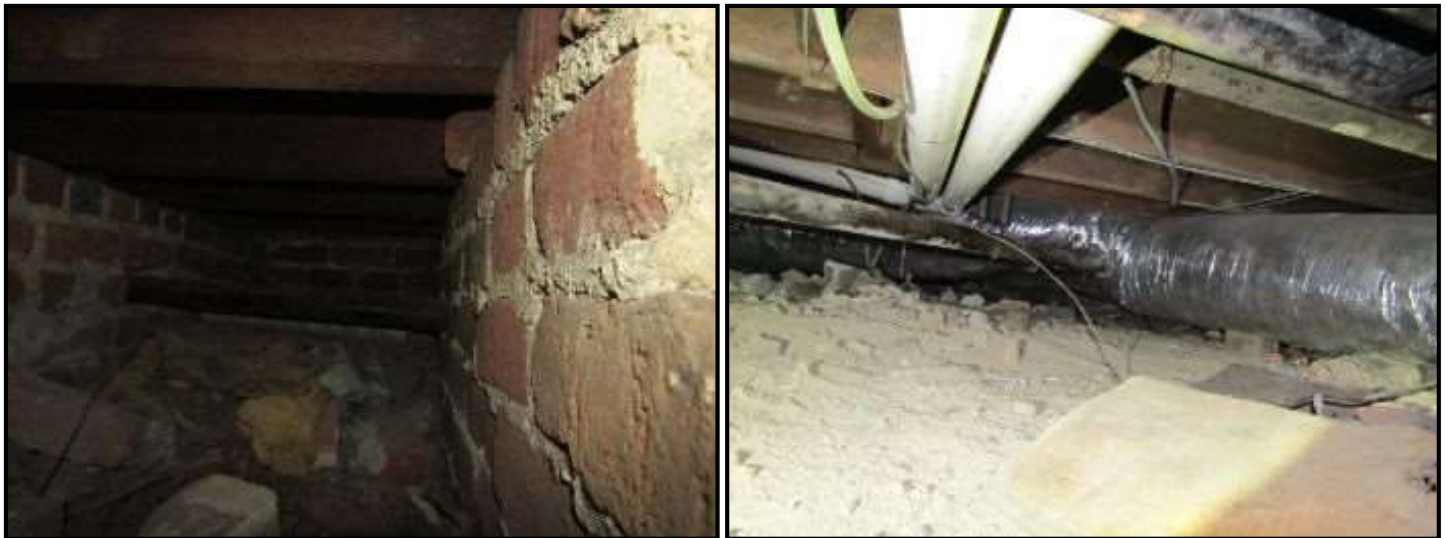
- The vapor barrier is missing in some areas of the crawlspace. Recommend installing 6 mil polyethylene with seams overlapped at least 24" so no soil is exposed in the crawlspace.

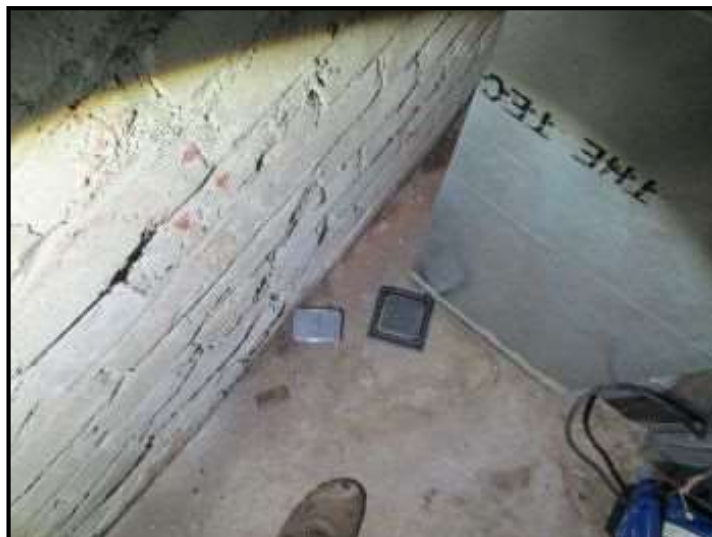
- Evidence of "light to moderate" rodent infestation was found in one or more areas. The Center for Disease Control (CDC) defines this as less than 20 feces per square foot. Rodent infestation may be a safety hazard due to the risk of contracting

Recommend following guidelines in the CDC's

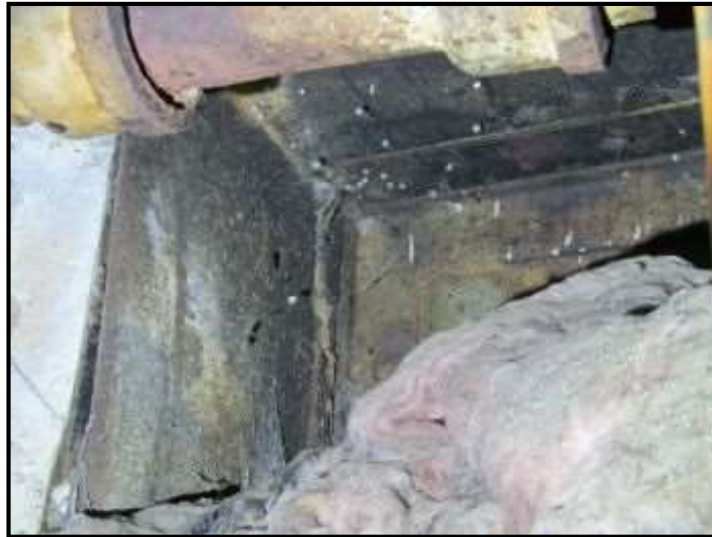
- **Evidence of wood destroying insects. Recommend evaluation, treatment and repair by a licensed pest control contractor.**

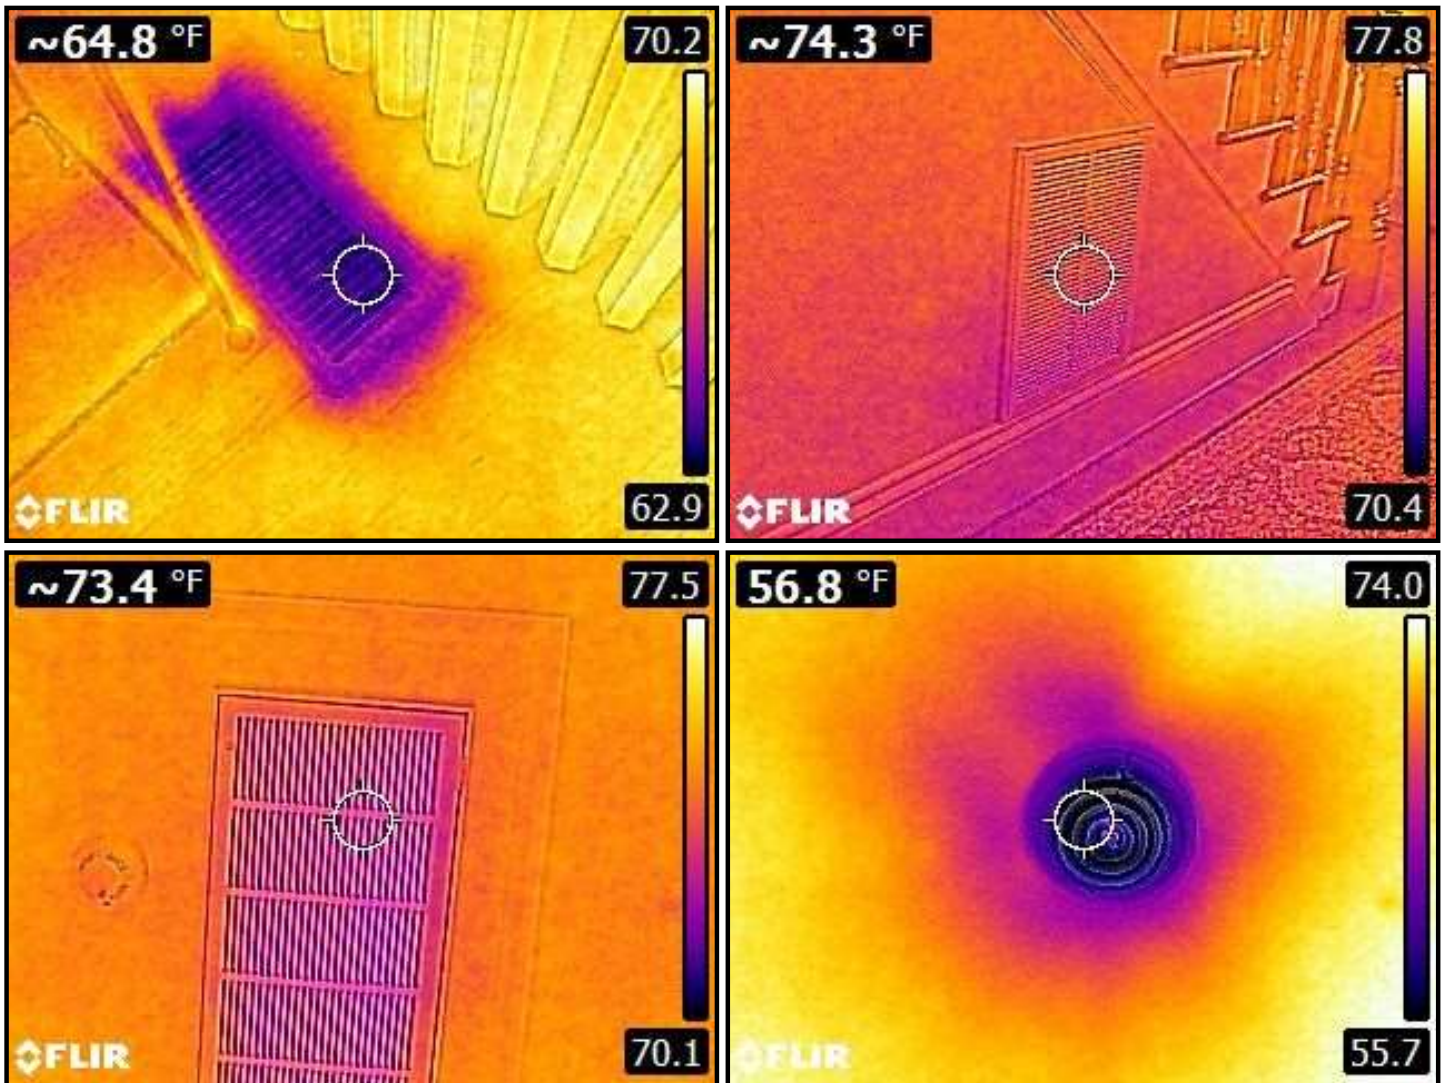
- The second floor of the home is equipped with a Trane central **A/C** unit that operated properly at the time of the inspection.
- The typical temperature differential split between supply and return air in an air conditioner of this type is 16 - 20 degrees F. This system responded and achieved an acceptable differential temperature of 17 degrees F.
- **The first floor of the home is equipped with an American Standard central A/C unit that did not operate properly at the time of the inspection. The typical temperature differential split between supply and return air in an air conditioner of this type is 16 - 20 degrees F. This system responded with a differential temperature of 10 degrees F. Recommend repair or replace by a licensed HVAC contractor.**

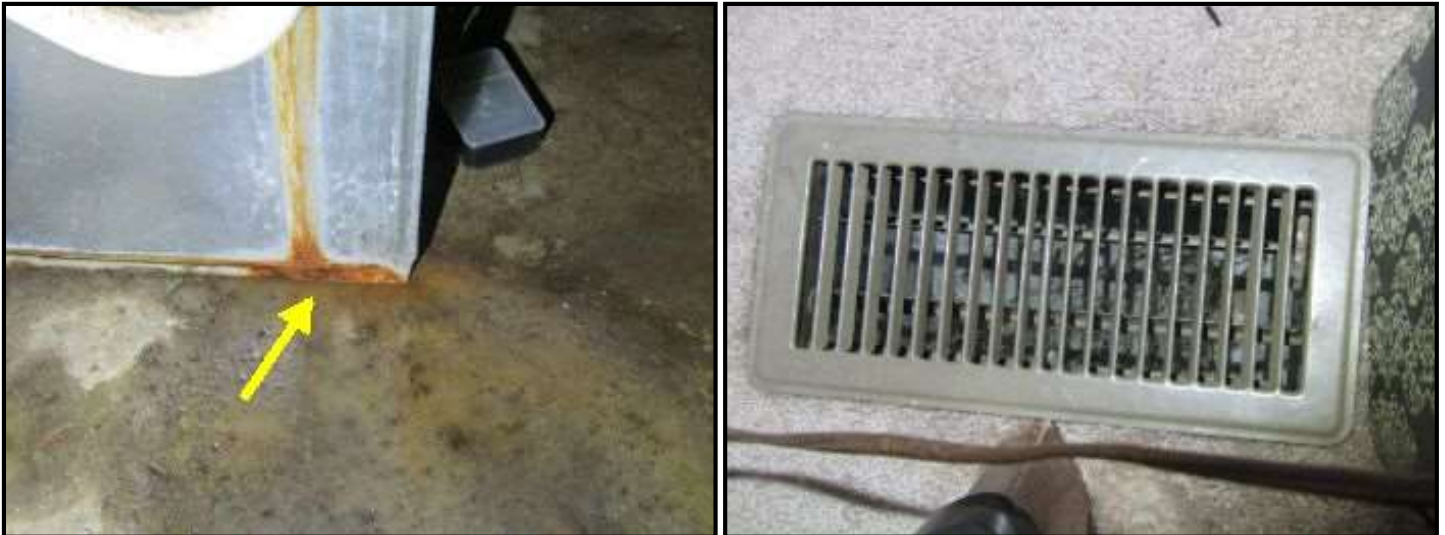
• Significant amounts of debris, dirt and/or dust are visible in one or more sections of supply and/or return air ducts. This can be a health hazard, especially for those with allergies or respiratory problems. The Environmental Protection Association (EPA) recommends considering having ducts professionally cleaned when "Ducts are clogged with excessive amounts of dust and debris and/or particles are actually released into the home from your supply registers". At a minimum, the visible debris should be thoroughly cleaned. The client may wish to have a qualified service provider professionally clean the ducts. For more information on duct cleaning in relation to indoor air quality, visit: <http://www.epa.gov/iaq/pubs/airduct.html>
350.00 - 550.00

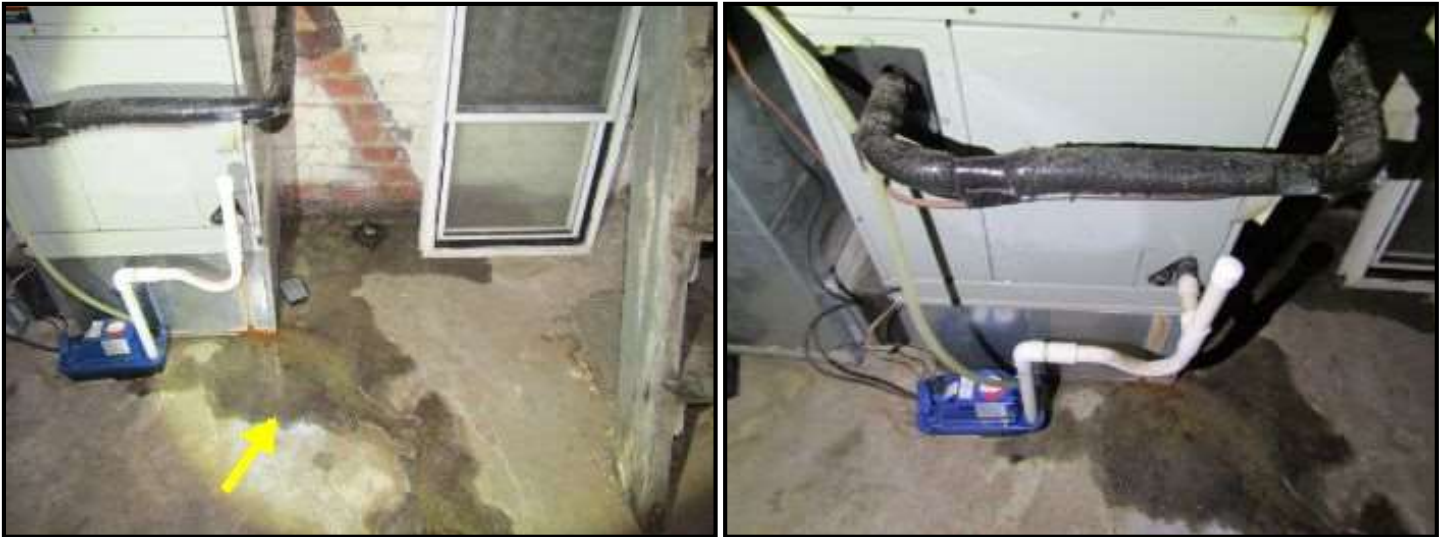
- There is excess rust at the bottom of the air handler in the basement and condensation leaking into the basement floor area. Recommend repair by a licensed HVAC contractor.
300.00 - 400.00
