HouseProbe Inspections

18 Marshall Street , Petersburg , VA 23803
Inspection prepared for: Linwood James & Kimberly James
Date of Inspection: 6/12/2021 Time: 4:30
Age of Home: 166 Size: 2675
Weather: Overcast

Inspector: Chris DiRienzo
License #3380001285
11309 courthouse Road, Dinwiddie, VA 23841
Phone: 804-731-9061
Email: HouseProbe@gmail.com
www.housprobe.com

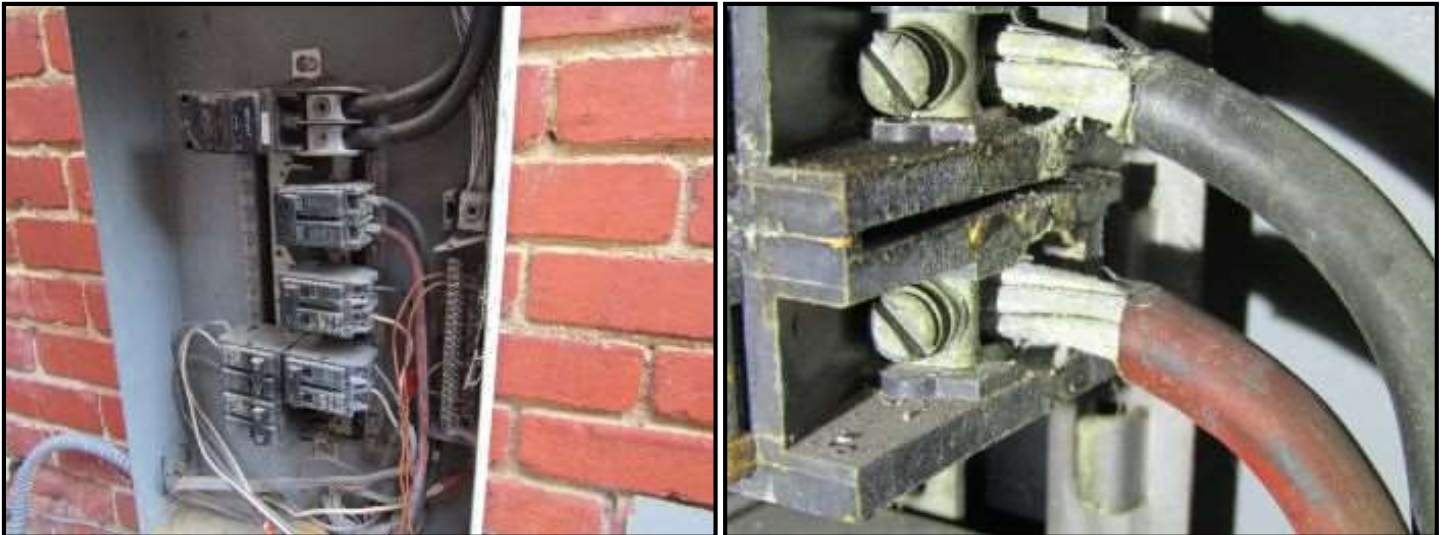
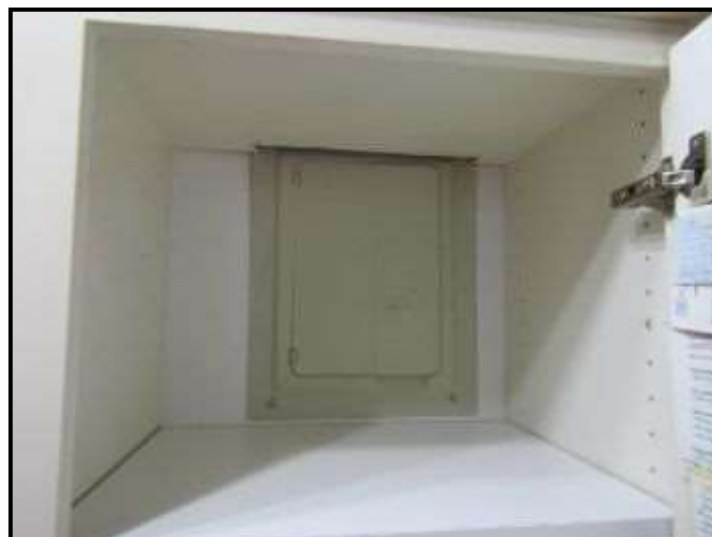
- **Recommend maintaining 30" of clear space in front of the electrical panel.**
- **Inadequate clearance exists to the kitchen subpanel. The sub panel is inside a kitchen cabinet and the cover cannot be removed due to the cabinet**
Recommend having a qualified, licensed electrician make modifications as necessary so:

- **Corrosion at the wire ends in panel box. Recommend repair by a licensed electrician.**

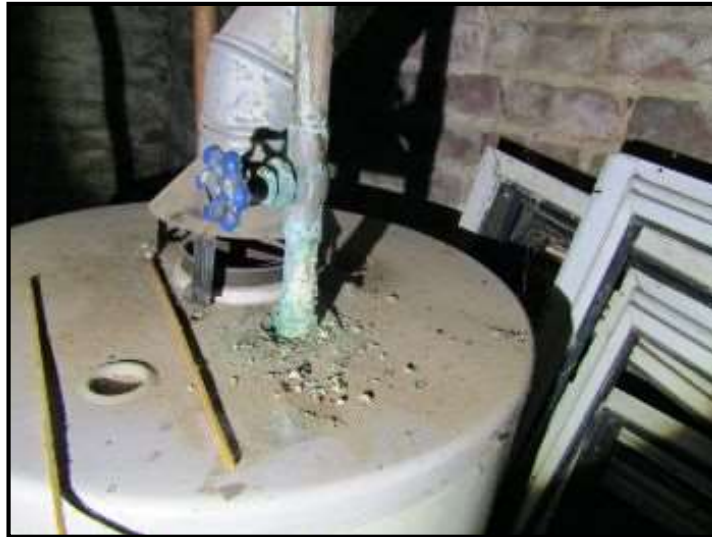
- There is rust or corrosion at the water heater plumbing. Recommend repair by a licensed plumbing contractor.
200.00 - 300.00

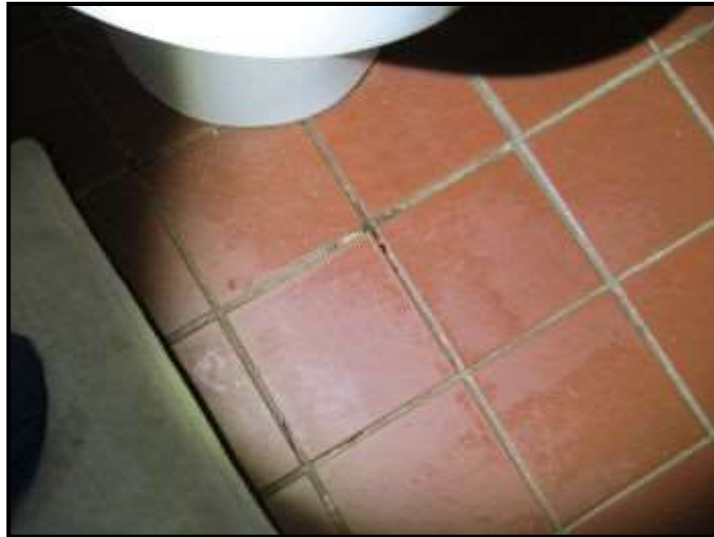
- **Damaged grout observed and cracked tiles, suggest regrouting and repair as necessary.
200.00 - 300.00**

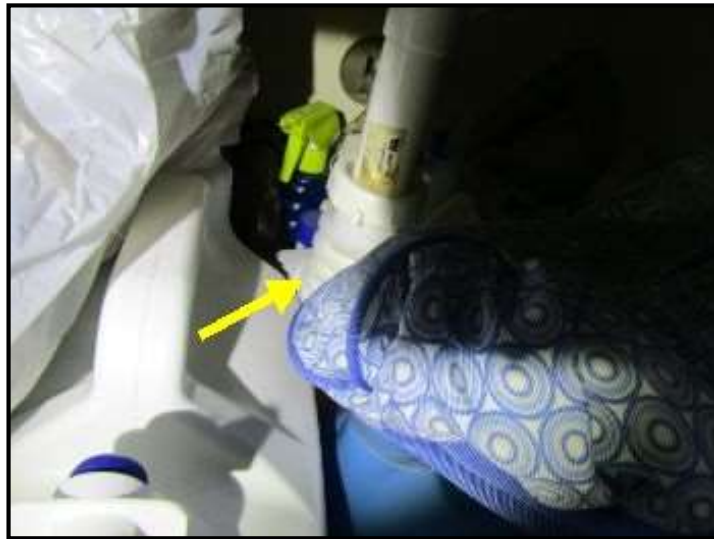
- **Flex drain observed, these are subject to frequent clogging.**

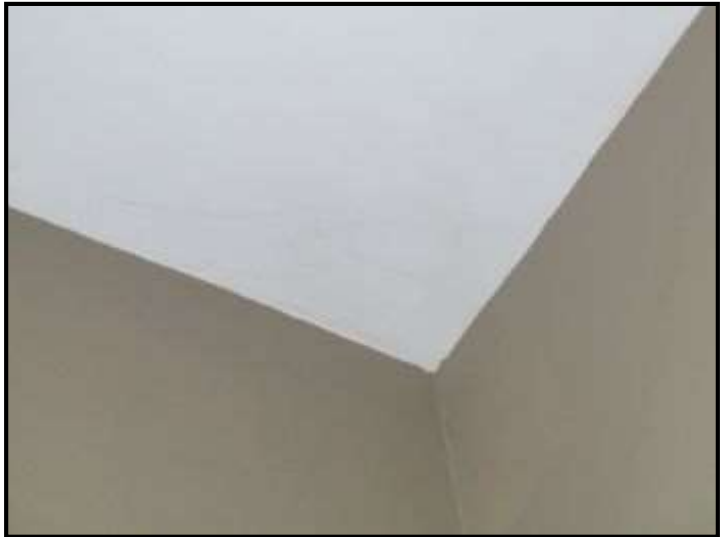
- **Small stains noted on the ceiling. They tested dry at the time of the inspection.**
- **There were signs of paint blistering or peeling on the ceiling. Recommend repair by a licensed contractor.
100.00 - 200.00**

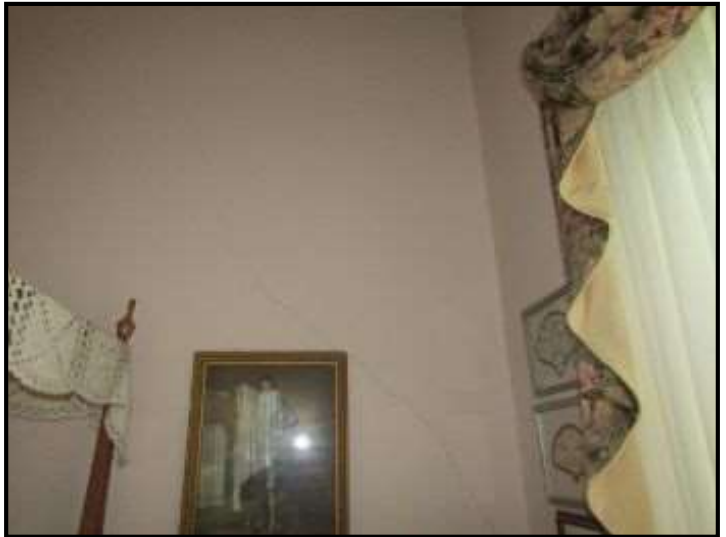
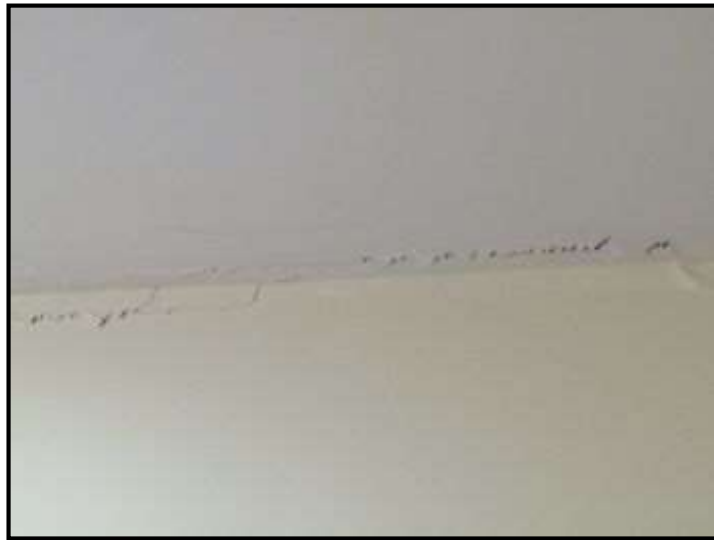
- **There are cosmetic drywall cracks and imperfections noted.**

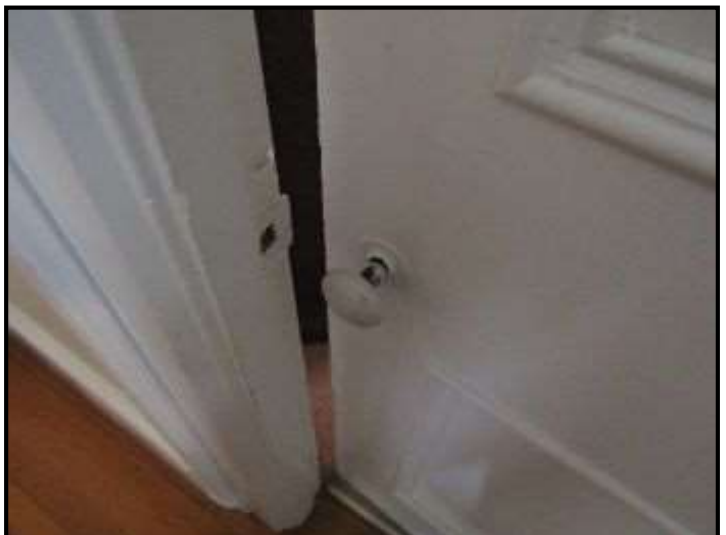
- **Some doors do not latch properly or stick in the frame when closed.**
Recommend repair by a licensed contractor.
200.00 - 300.00

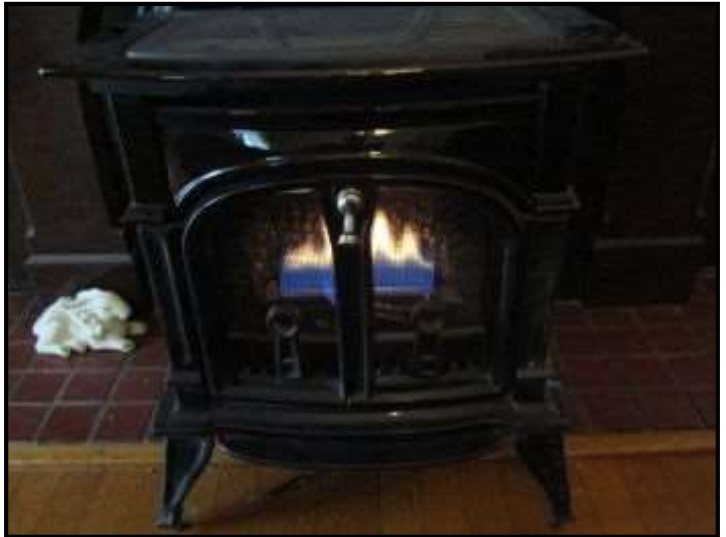
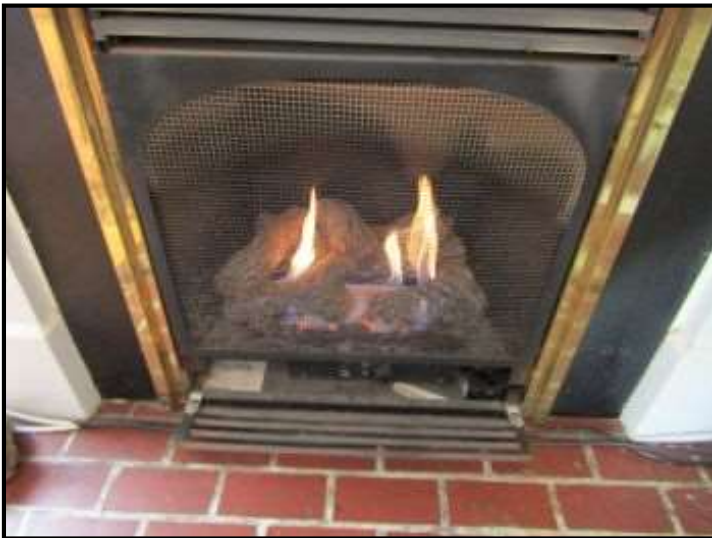
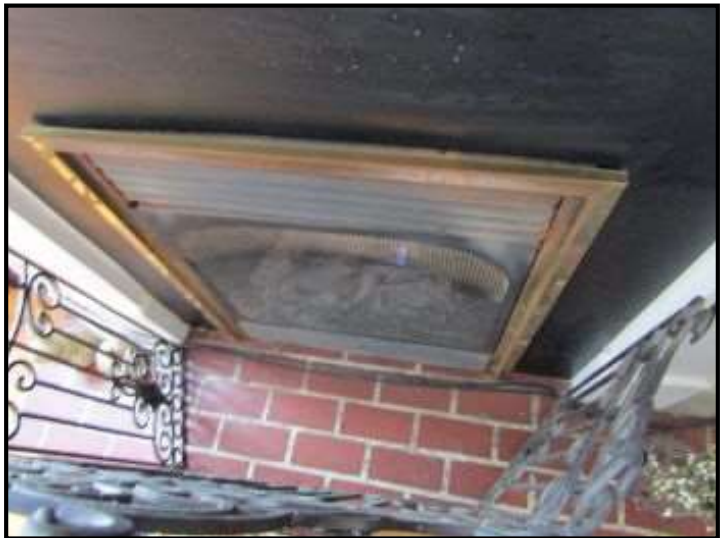
• **There was a strong gas smell at the second floor bedroom gas logs. Recommend repair by licensed contractor. 300.00 - 400.00**

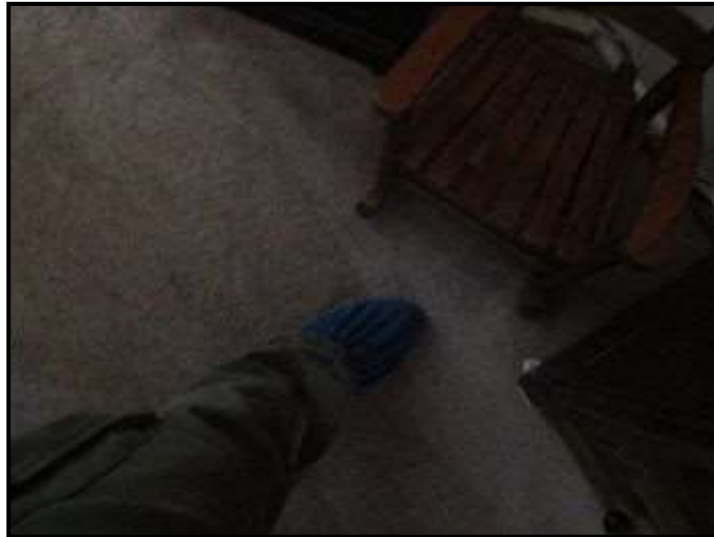
• Walking on some sections of the floor results in squeaking or creaking noises. This is usually the result of substandard construction practices where the subfloor decking isn't adequately fastened (insufficient glue) to the framing below. In most cases, this is an annoyance only rather than a structural problem. Various solutions such as [[url="http://www.oberry-enterprises.com"](http://www.oberry-enterprises.com)]Squeeeeeek No More and Counter Snap fasteners[/[url](http://www.oberry-enterprises.com)] exist to correct this. Repairs to eliminate the squeaks or creaks may be more or less difficult depending on there being finished hardwood floors, carpeting over the subfloor, and/or clear access to the underside of the subfloor. Recommend having a qualified contractor evaluate and repair as necessary.

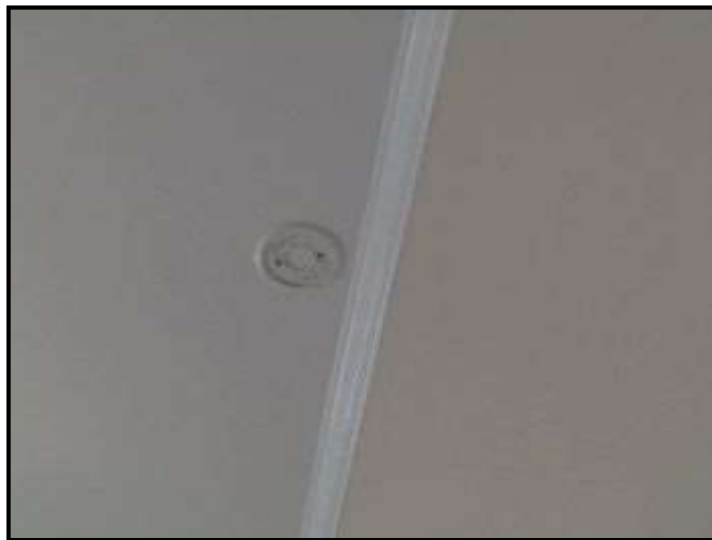
- **One or more smoke detectors is damaged or missing, and an insufficient number of smoke detectors are installed. Recommend replacing inoperable smoke detectors as necessary, and installing additional smoke detectors as necessary so a functioning one exists in each hallway leading to bedrooms, and in each bedroom. For more information on smoke detectors visit <http://www.cpsc.gov/cpsc/pub/pubs/5077.html> 50.00 - 75.00**

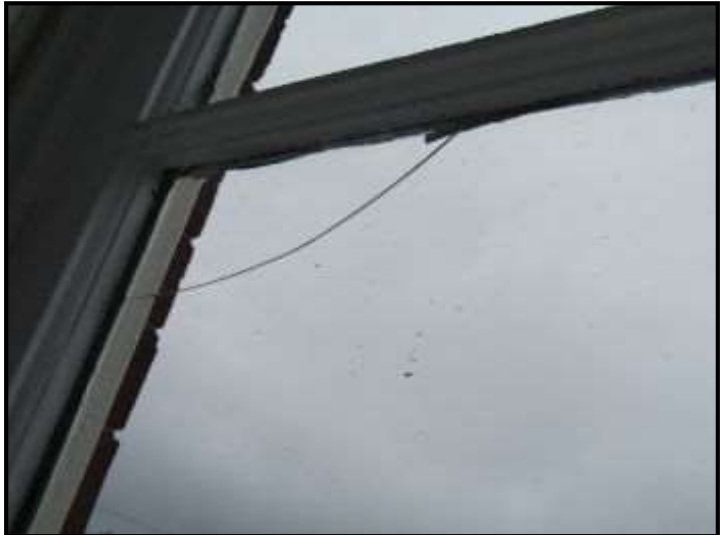
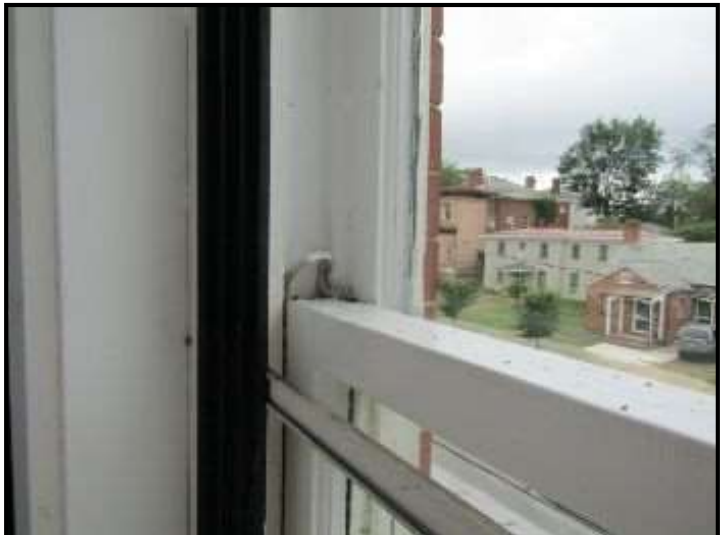
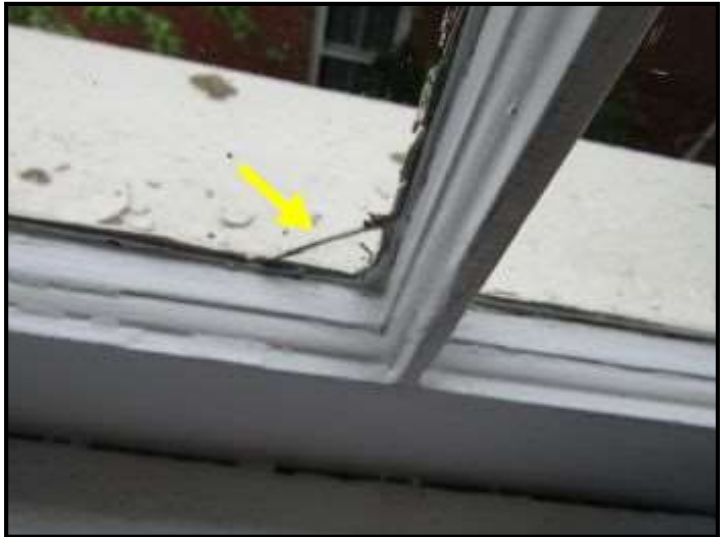
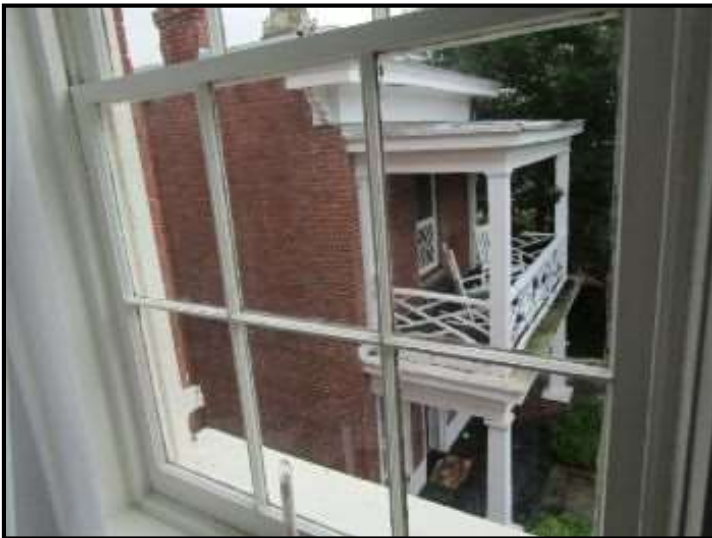
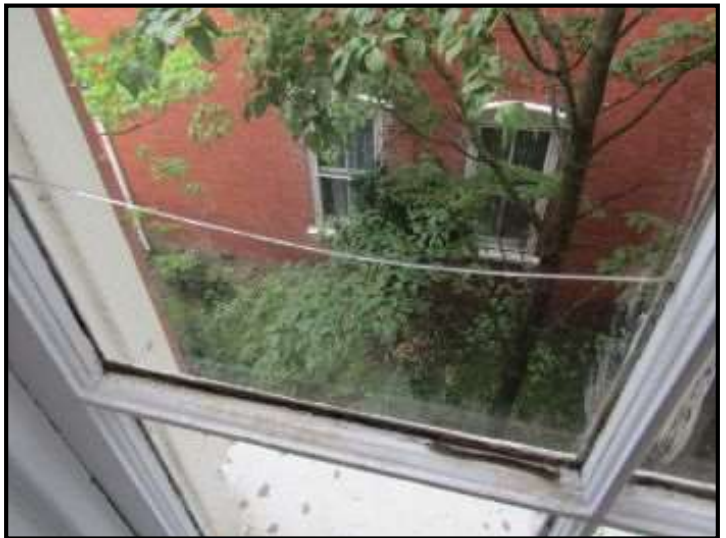
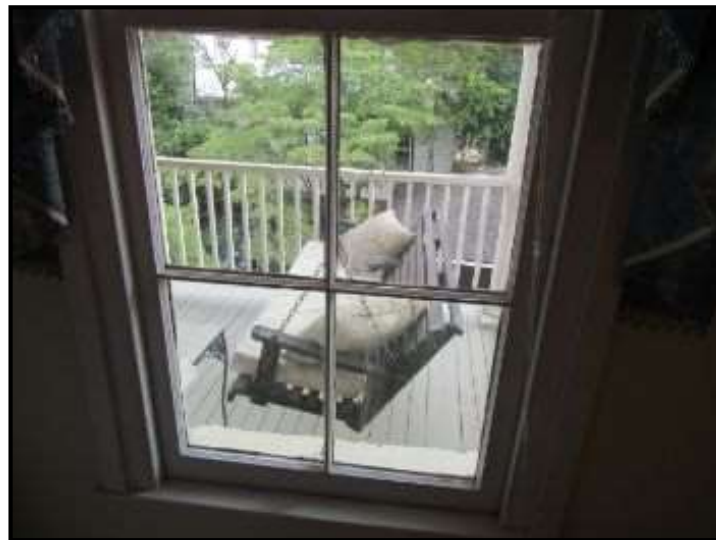
- **There is a broken window noted. Recommend repair by a licensed contractor. 250.00 - 350.00**
- **Some interior windows are painted shut. This is a safety hazard in event of fire. Recommend repair by a licensed contractor. 400.00 - 500.00**

- **Broken sash wire/cord observed on window frame. This is a "Safety Concern". Sash wire/cord holds window in open position. Suggest repairs/replacement as needed to ensure safety. 100.00 - 200.00**

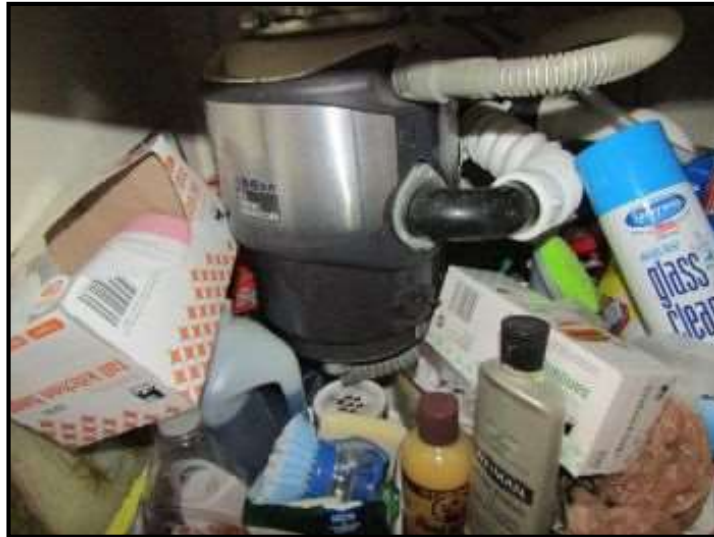
- **The unit makes irregular noise. This may be a foreign object stuck in the disposal. Recommend repair by a licensed plumbing contractor.**

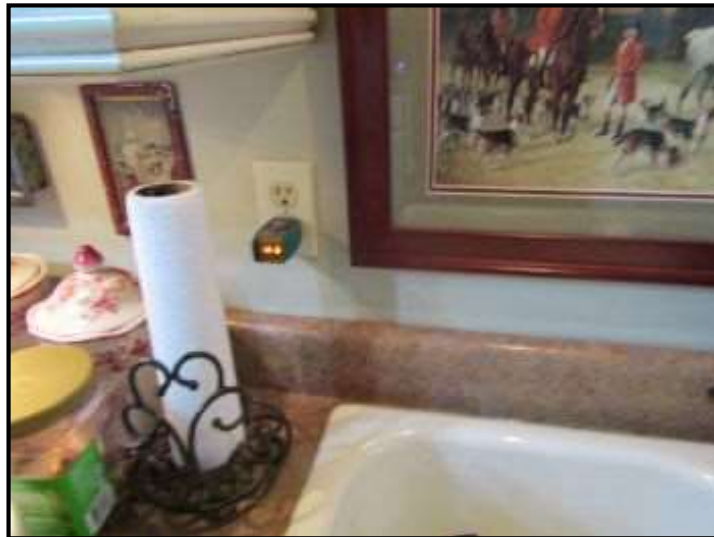
- **No GFCI protection present, suggest installing GFCI protected receptacles for safety.**

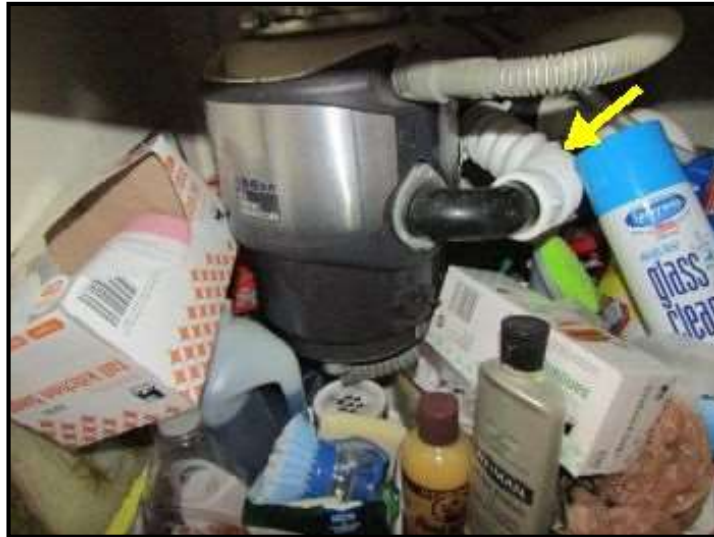
- Flex drain observed, these are subject to frequent clogging.
150.00 - 250.00

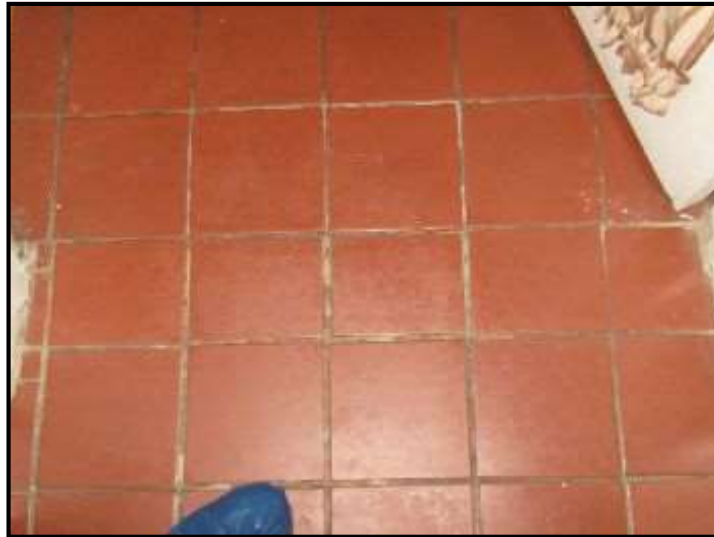
- **There is floor damage noted in the laundry closet. Recommend repair.
250.00 - 350.00**
