HouseProbe Inspections

18 Marshall Street , Petersburg , VA 23803
Inspection prepared for: Linwood James & Kimberly James
Date of Inspection: 6/12/2021 Time: 4:30
Age of Home: 166 Size: 2675
Weather: Overcast

Inspector: Chris DiRienzo
License #3380001285
11309 courthouse Road, Dinwiddie, VA 23841
Phone: 804-731-9061
Email: HouseProbe@gmail.com
www.housprobe.com

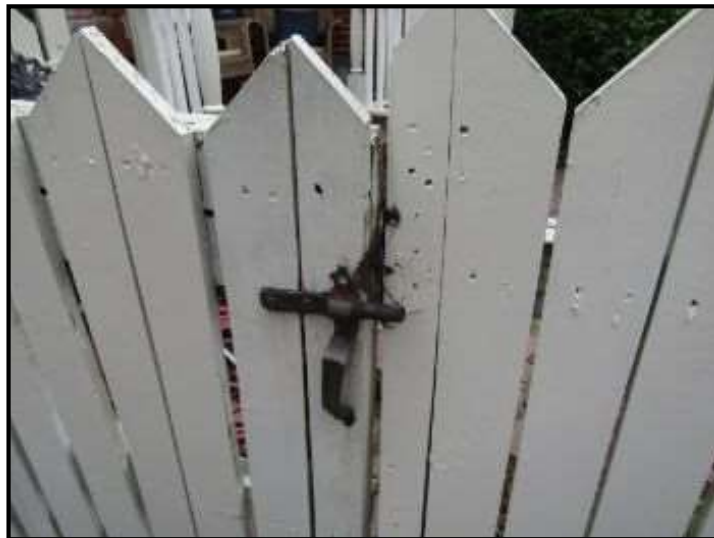
- **Gate is sagging.**
- 50.00 - 75.00**

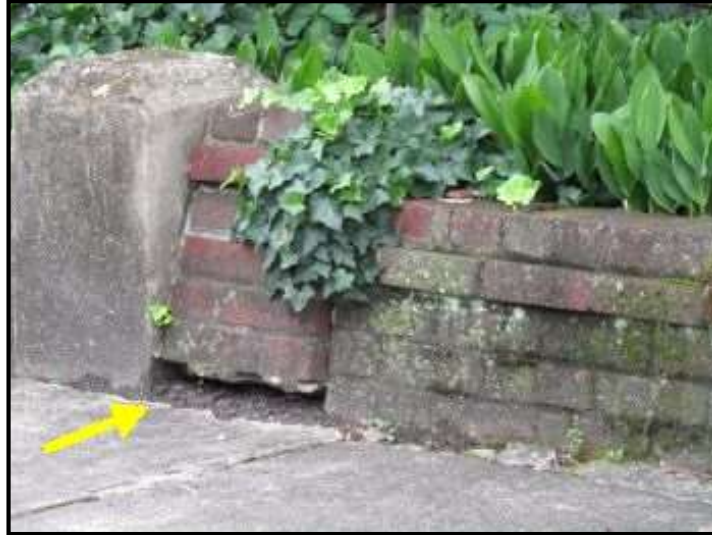
- **There are loose brick post at the retaining wall. This is a possible safety hazard. Recommend securing blocks as needed. 200.00 - 300.00**

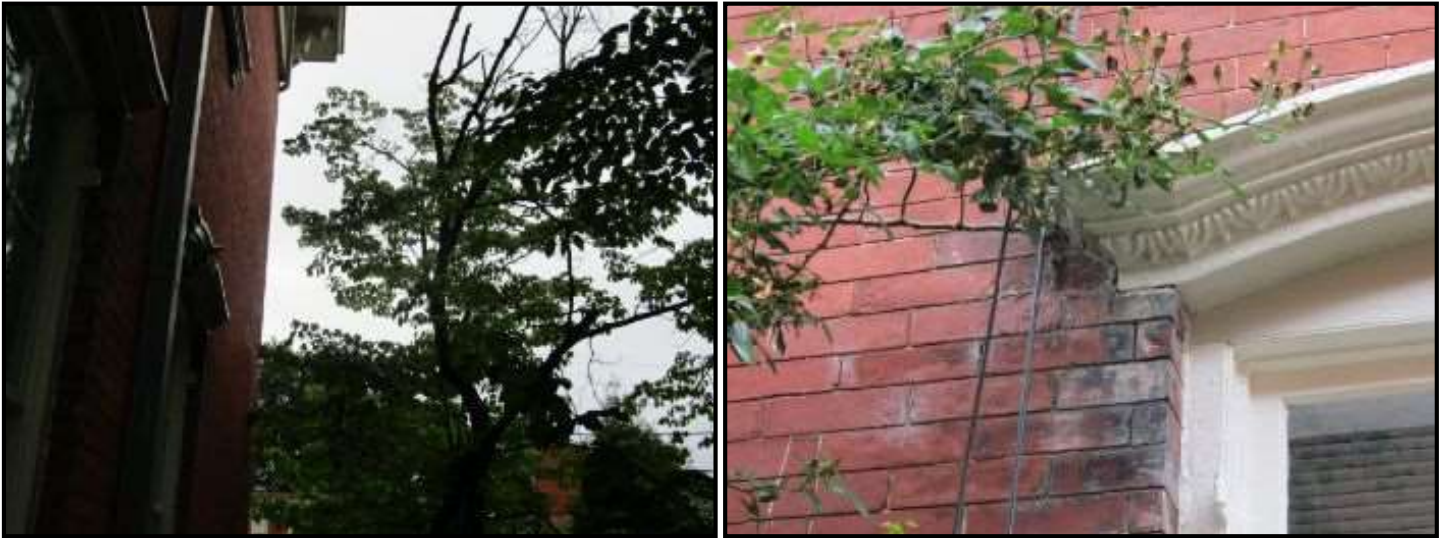
- Prune or remove any plants that are in contact or proximity to home to eliminate pathways of wood destroying insects.
- Tree limbs within 10 feet of roof should be trimmed away to provide air and sunlight to roof, while minimizing debris & dampness.

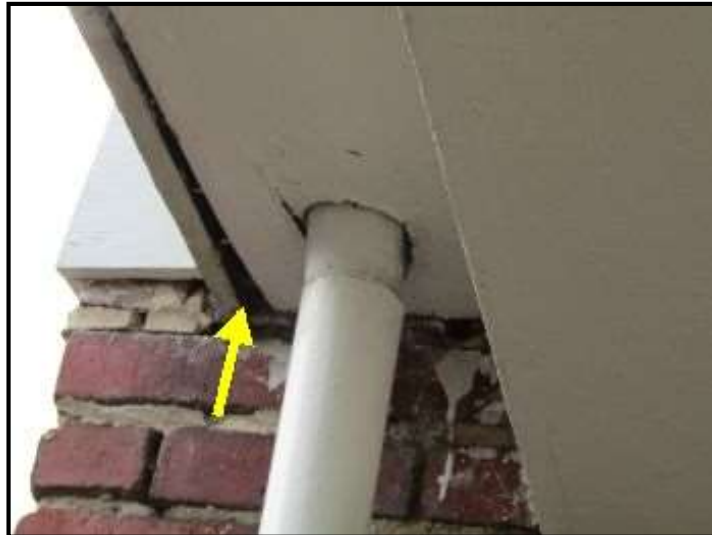
- **There is wood trim deterioration at the soffit and trim. Recommend repair by a licensed contractor. 1,000.00 - 2,000.00**

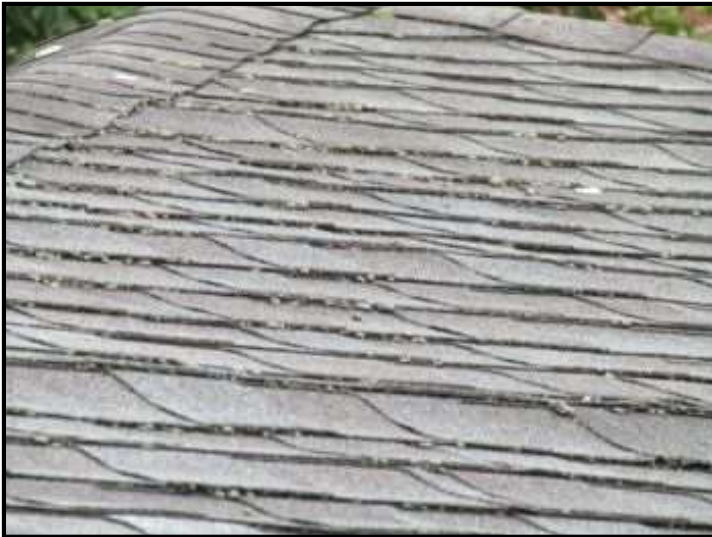
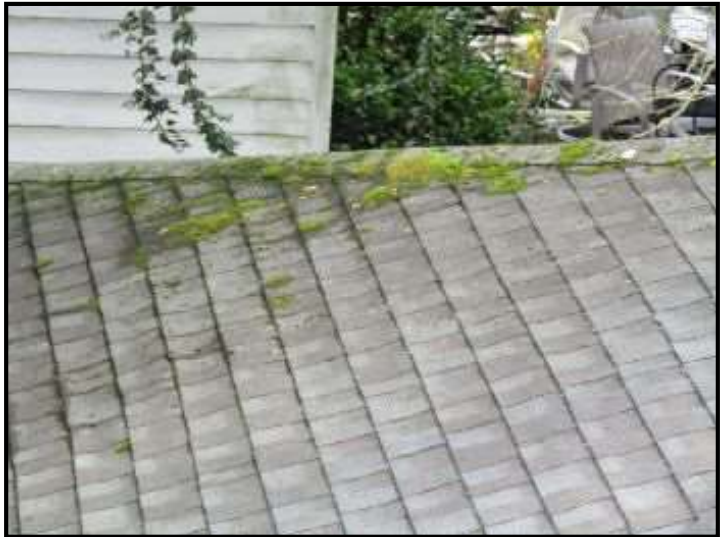
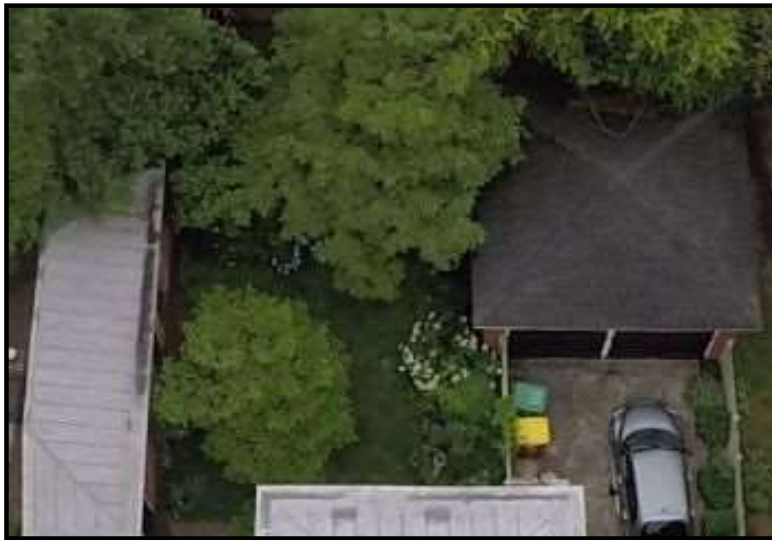
• The roof appears to be in serviceable condition with normal wear and granule loss.

• Moss is growing on the roof. This is a conducive condition for wood destroying insects and organisms which can lead to the premature failure of the roof and subsequent leaks. Recommend treating moss during its growing season (wet months) with a moss killer. For information on various moss treatment products and their pros and cons, visit

250.00 - 350.00

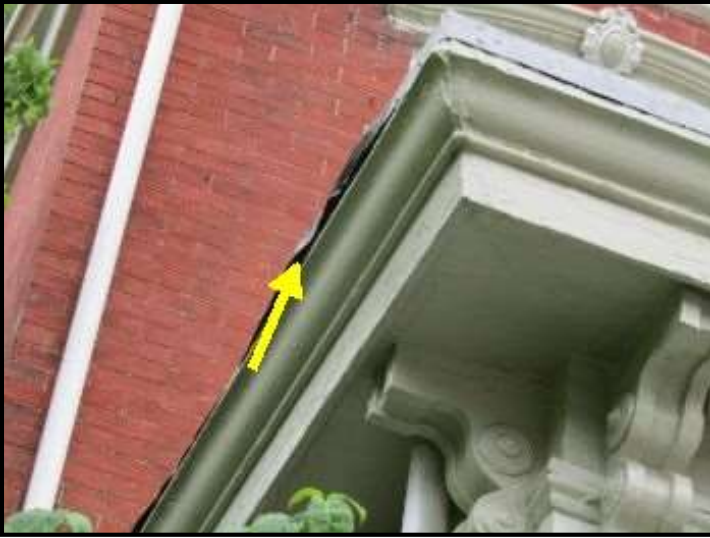
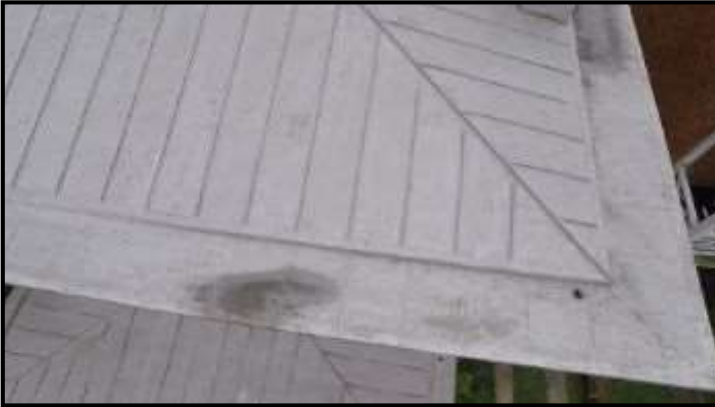
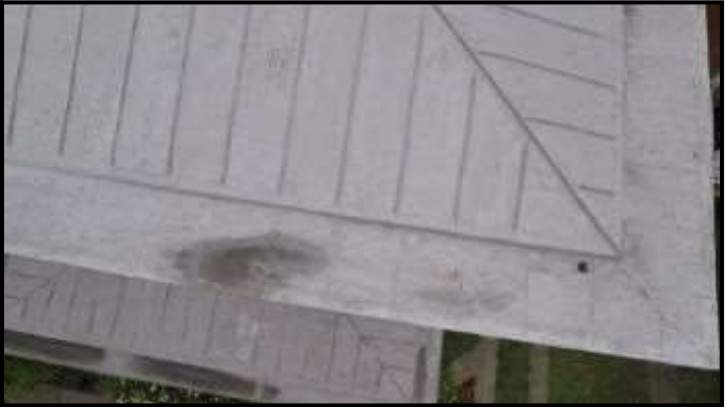
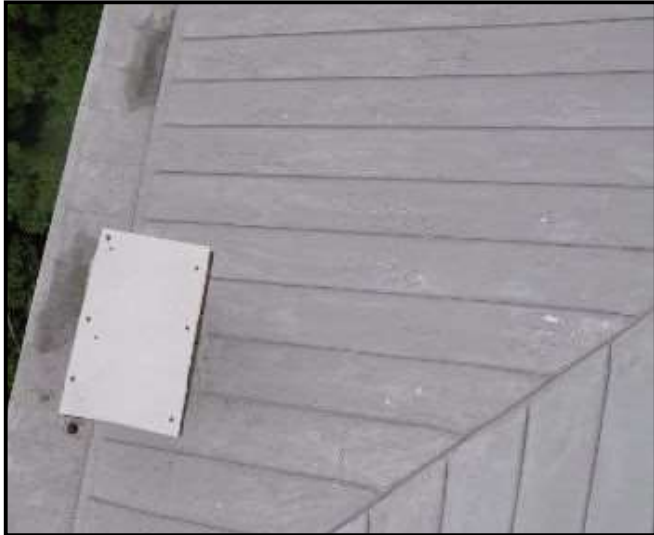
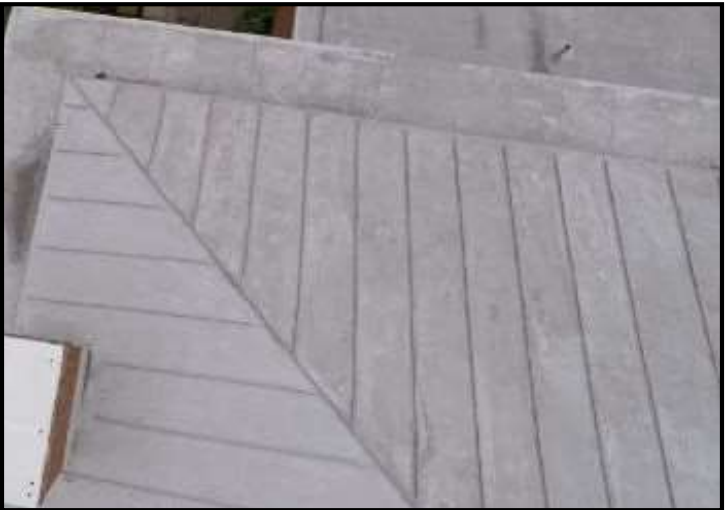
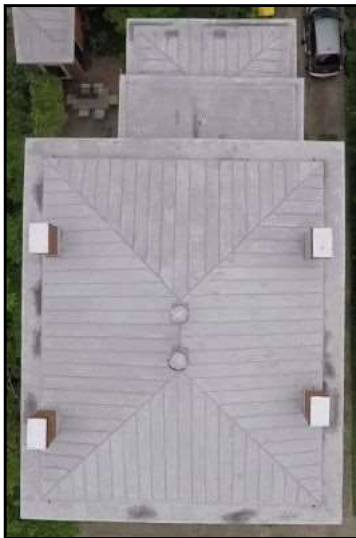
- The roof structure appears to be in serviceable condition with normal wear. However, the paint and sealing is deteriorated and the roof flashing is pulling away at the porch roof. This a metal roof and it will require maintenance of spot painting and sealing.
2,000.00 - 3,000.00

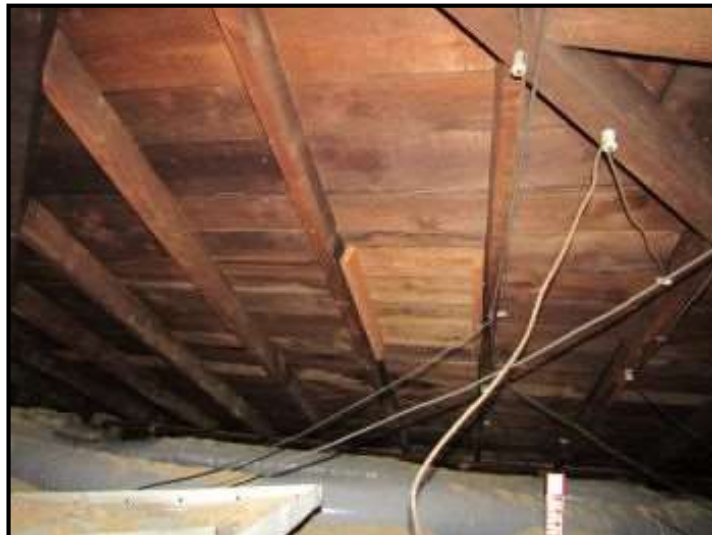
- **Live knob and tube wiring present(K&T). This is an obsolete system and a safety and fire hazard. Due to insulation covering wires and any modifications to the wiring. There is no ground wire and cannot service three-pronged appliances. Some home insurance companies will not insure homes with K&T. Recommend evaluation of K&T and ensure to be in serviceable condition. 1,250.00 - 1,350.00 or Quote**

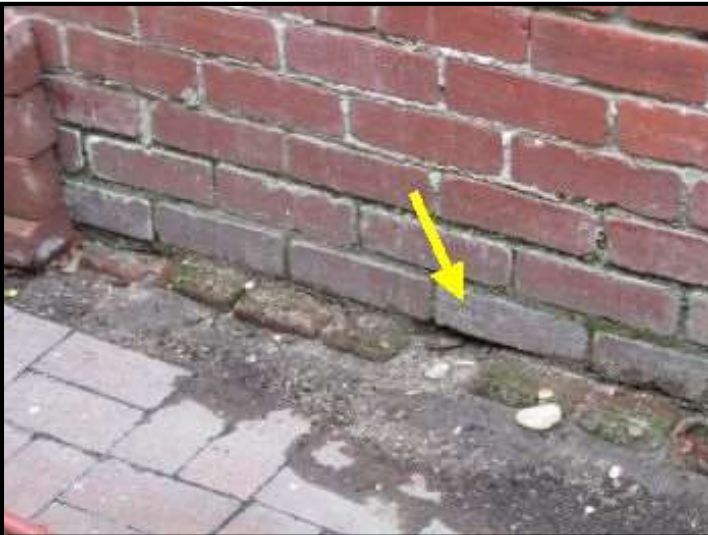
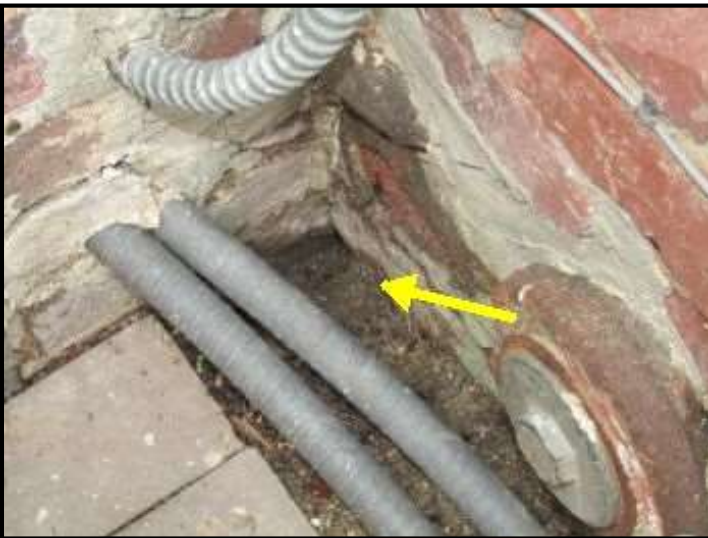
- **There are holes in the foundation large enough for rodent intrusion. Recommend filling or closing any holes with mortar or grout.**
 - **Cracks / Holes present in: foundation / floor / ext. wall. Recommend filling repair and sealing them to prevent water infiltration.**
- 1,000.00 - 2,000.00**

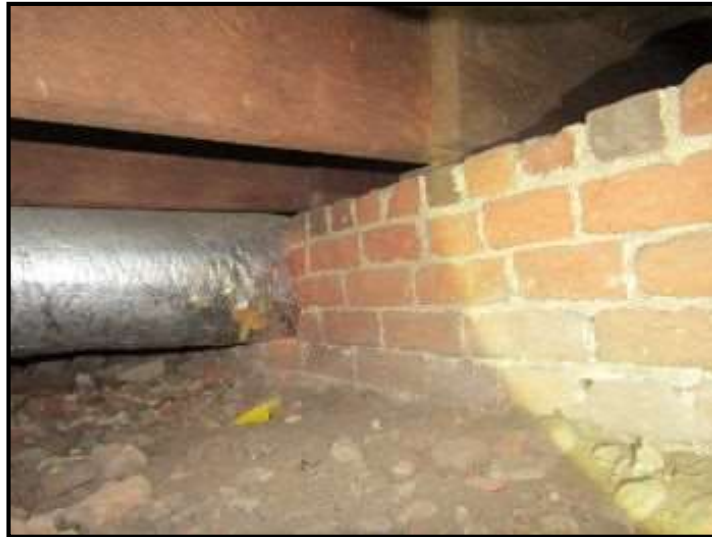
- The crawlspace access is limited due to plumbing lines, HVAC duct work and beam height.

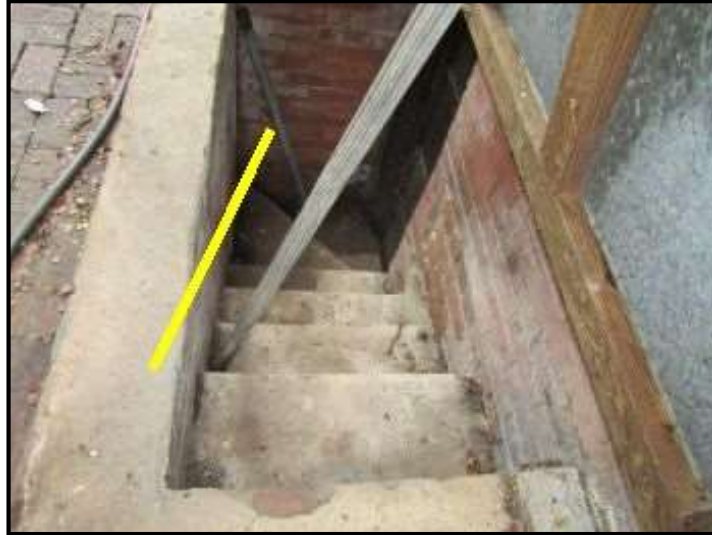
- **There is no handrail at the basement exterior stairs. This is a safety hazard. Recommend repair by a licensed contractor.**
100.00 - 150.00

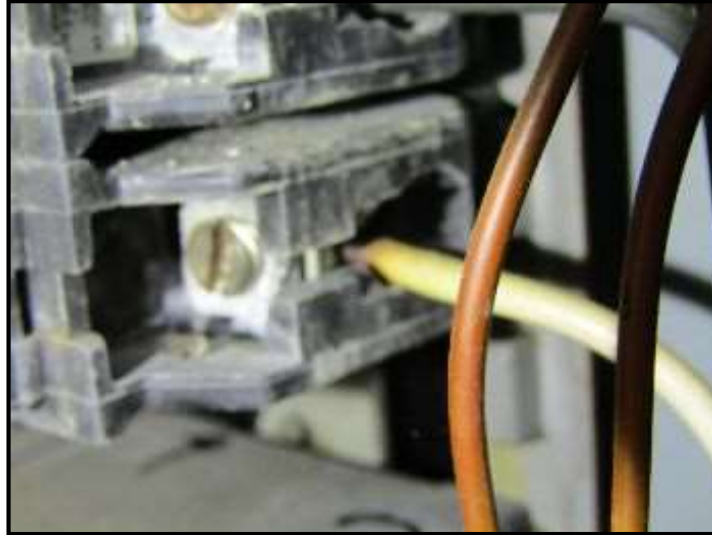
- **Burned or scorched wiring observed, recommend review by a licensed electrician.
200.00 - 300.00**

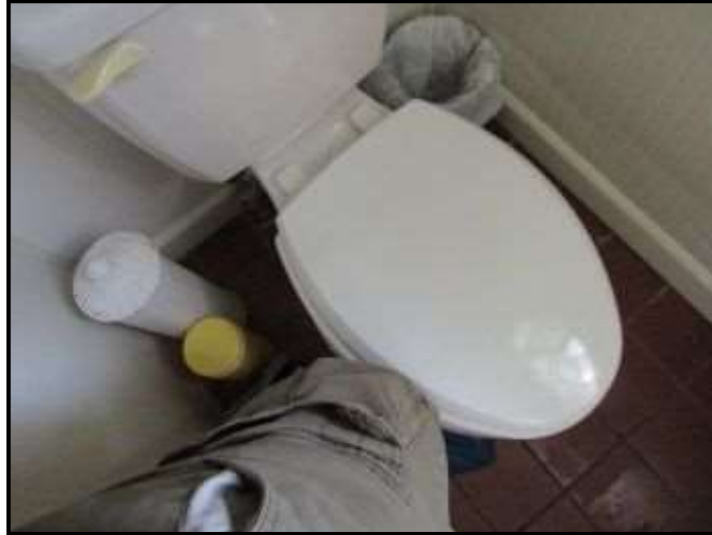
- **The first floor half bath toilet float needs adjustment. Recommend repair by a licensed contractor.
150.00 - 200.00**

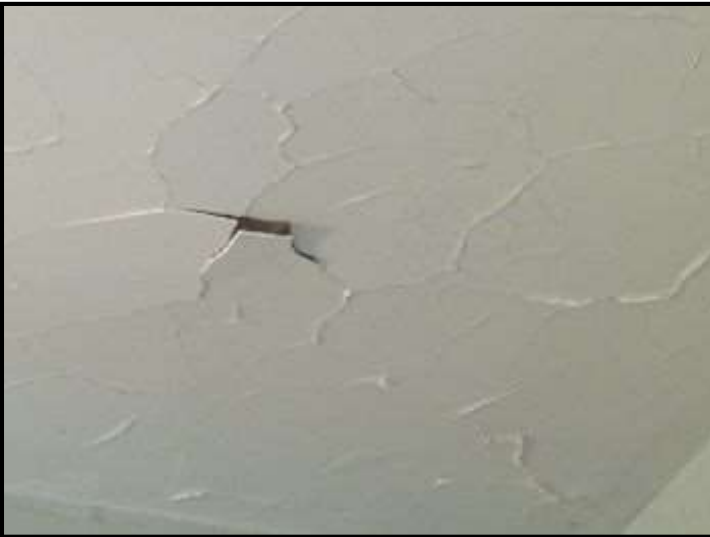
- **Small stains noted on the ceiling. They tested dry at the time of the inspection.**
- **There were signs of paint blistering or peeling on the ceiling. Recommend repair by a licensed contractor.
100.00 - 200.00**

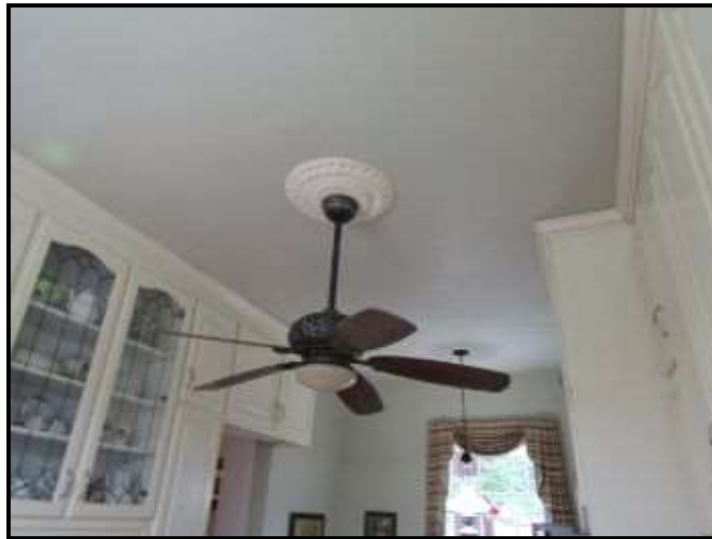
- **The ceiling fan did not operate when tested.**
50.00 - 75.00

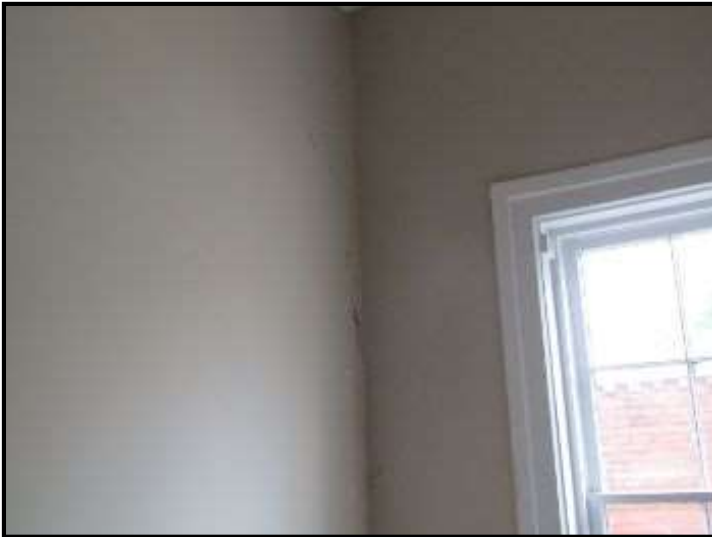
- **There are cosmetic drywall cracks and imperfections noted.**

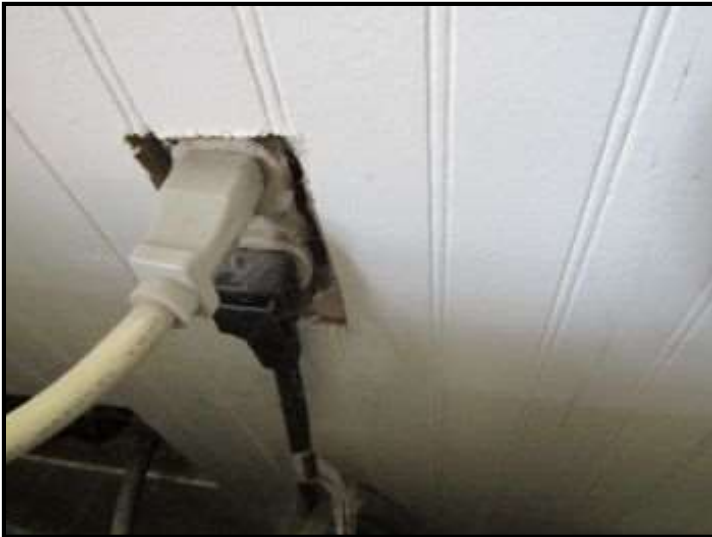
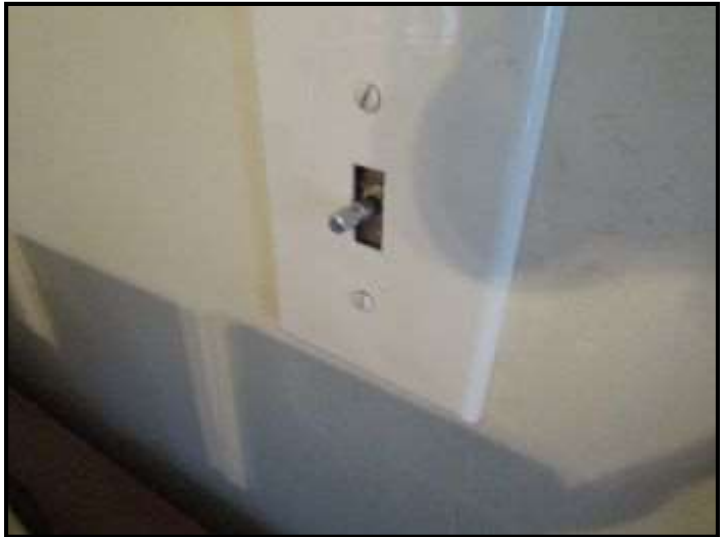
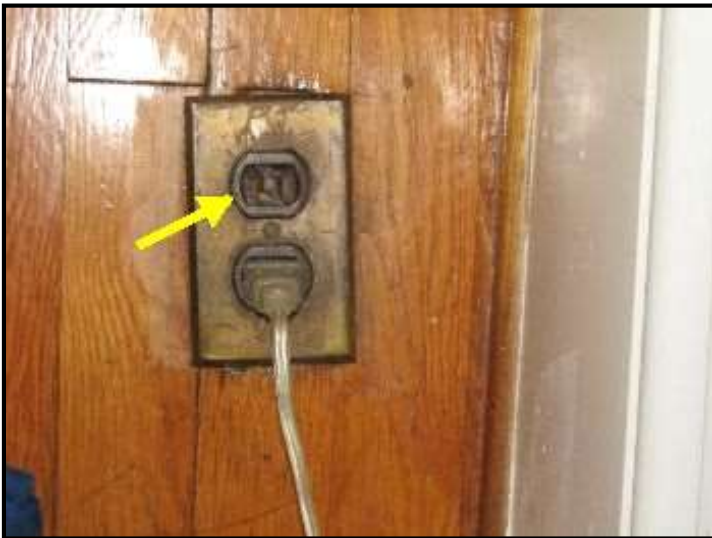
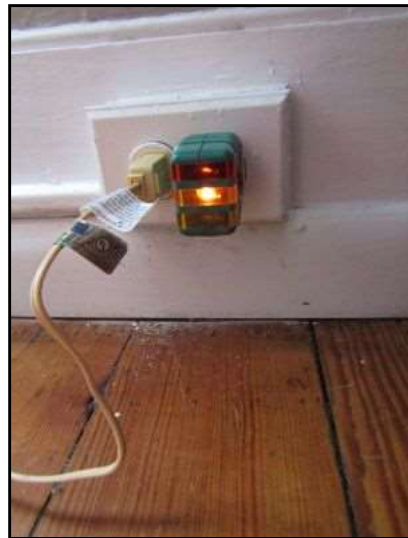
6. Electrical

The home contained outdated, ungrounded 2-prong electrical outlets. Although this condition may have been commonly considered safe or acceptable at the time the home was originally constructed, as general knowledge of safe building practices has improved with the passage of time, building standards have changed to reflect current understanding. Consider updating the existing condition to meet generally-accepted current standards.

• **Cover plate(s) are missing from one or more electric receptacle boxes and knobs from light switches. They are intended to contain fire and prevent electric shock from exposed wires. This is a safety hazard and poses a risk of both fire and shock. Recommend installing cover plates over receptacle boxes where missing.**

• **One or more open ground, 3-pronged receptacles were found. This is a safety hazard and poses a risk of electric shock. Recommend that a qualified, licensed electrician evaluate and make repairs as necessary. For example, replacing receptacles or correcting wiring circuits.**

Grounded receptacles began being required in residential structures during the 1960s. Based on the age of this structure and the presence of 2-pronged receptacles in some areas of this structure, an acceptable repair may be to simply replace the ungrounded 3-pronged receptacles with 2-pronged receptacles. However the following appliances require grounded receptacles:

1,000.00 - 2,000.00 or Quote

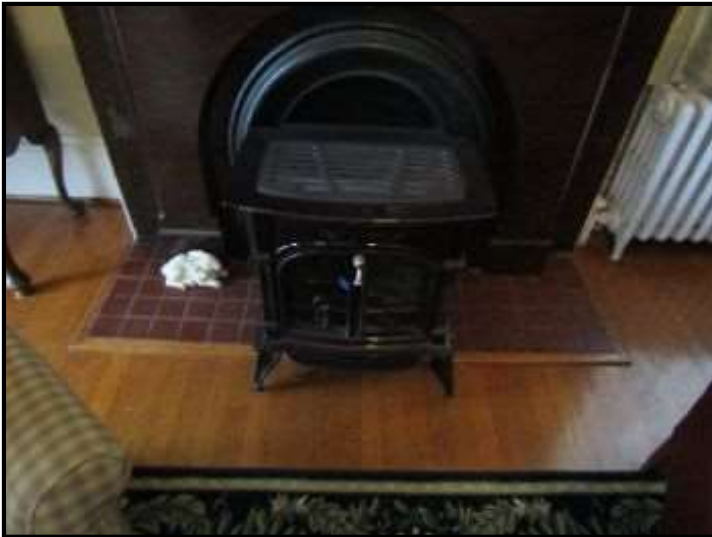
7. Fireplace

• **There was a strong gas smell at the second floor bedroom gas logs. Recommend repair by licensed contractor. 300.00 - 400.00**

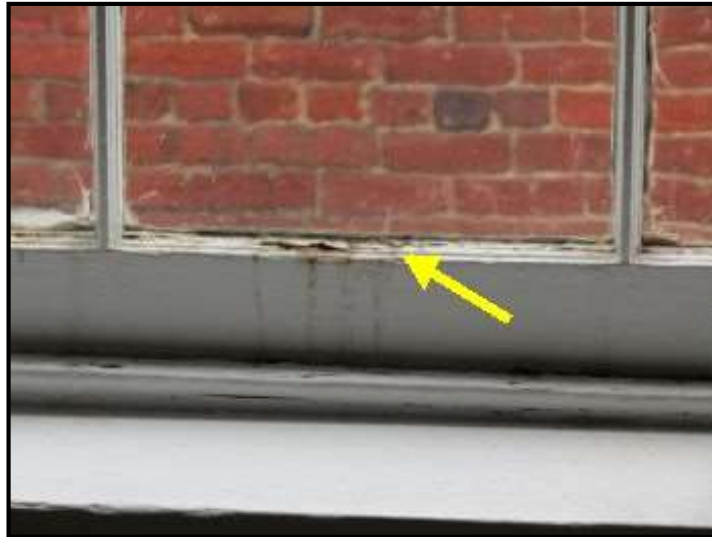
10. Moisture Intrusion

- There is evidence of moisture in the stairway wall window. Recommend repair by a licensed contractor.
100.00 - 200.00

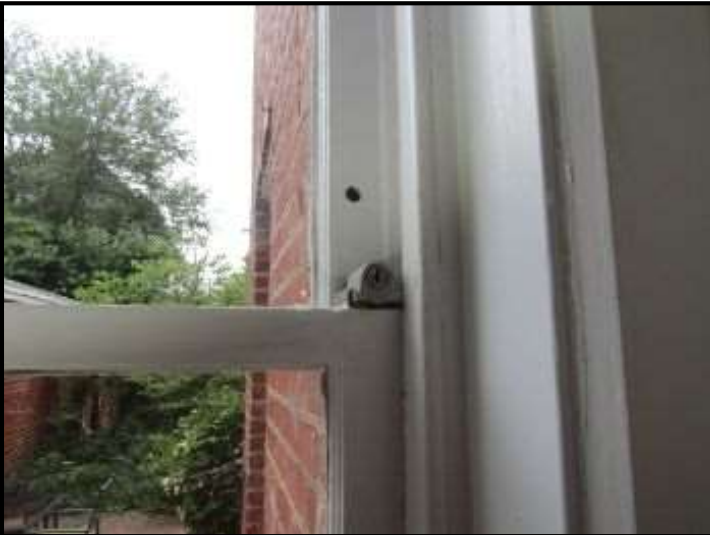
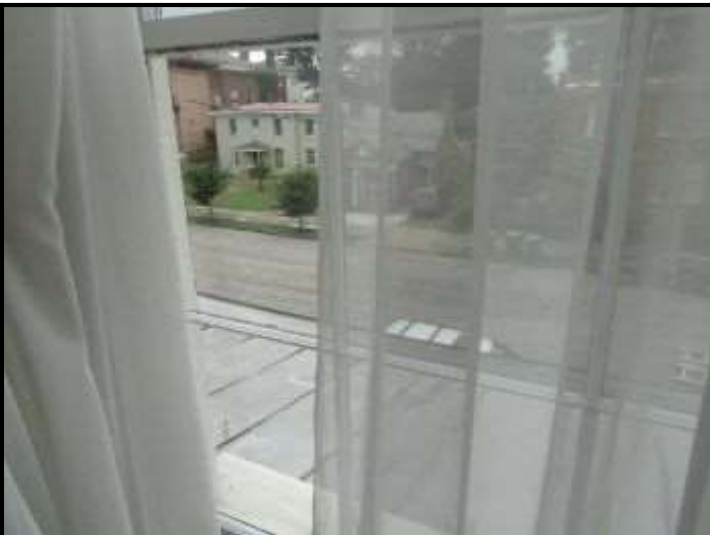
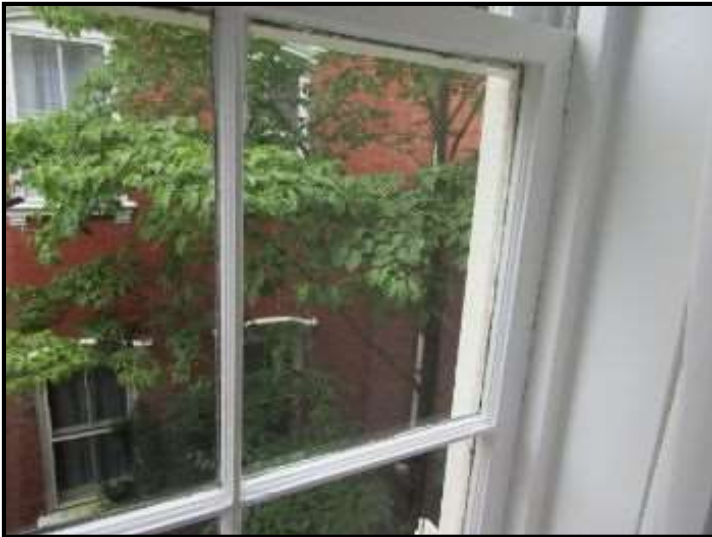
14. Window Condition

- **There is a broken window noted. Recommend repair by a licensed contractor. 250.00 - 350.00**
- **Some interior windows are painted shut. This is a safety hazard in event of fire. Recommend repair by a licensed contractor. 400.00 - 500.00**

- **Broken sash wire/cord observed on window frame. This is a "Safety Concern". Sash wire/cord holds window in open position. Suggest repairs/replacement as needed to ensure safety. 100.00 - 200.00**

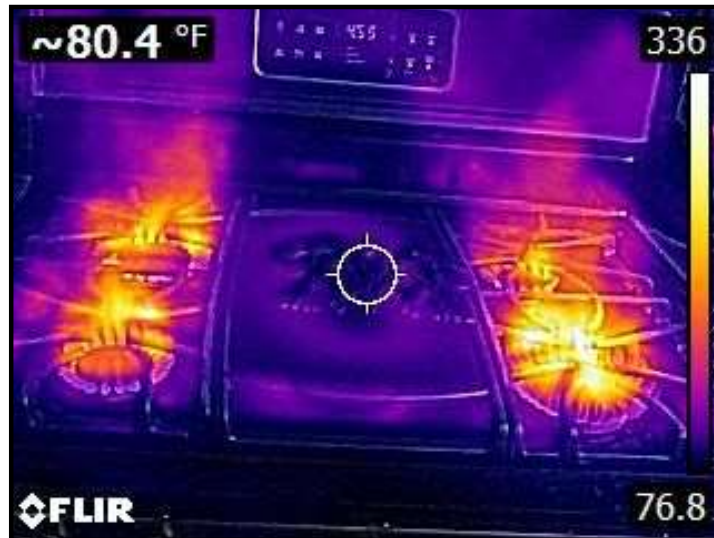
3. Cook top condition

- **Gas cook top noted.**

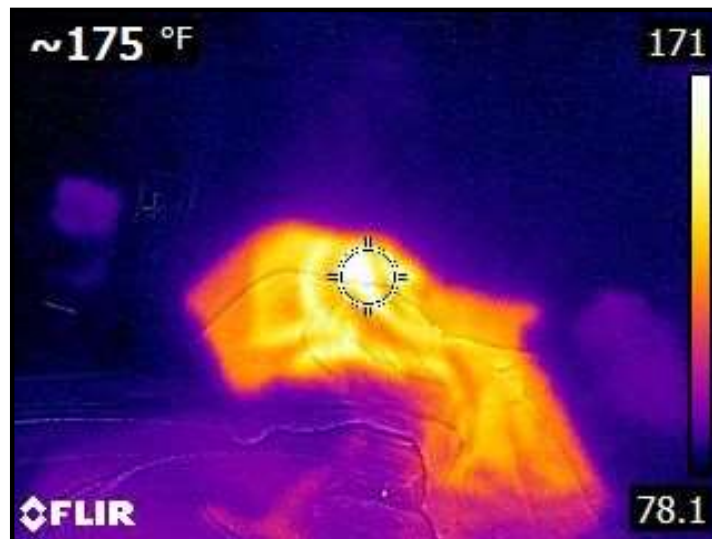
- **Built-in microwave ovens are tested using normal operating controls. Unit was tested and appeared to be serviceable at time of inspection. Leak and/or efficiency testing is beyond the scope of this inspection. If concerned, client should seek further review by qualified technician prior to closing.**

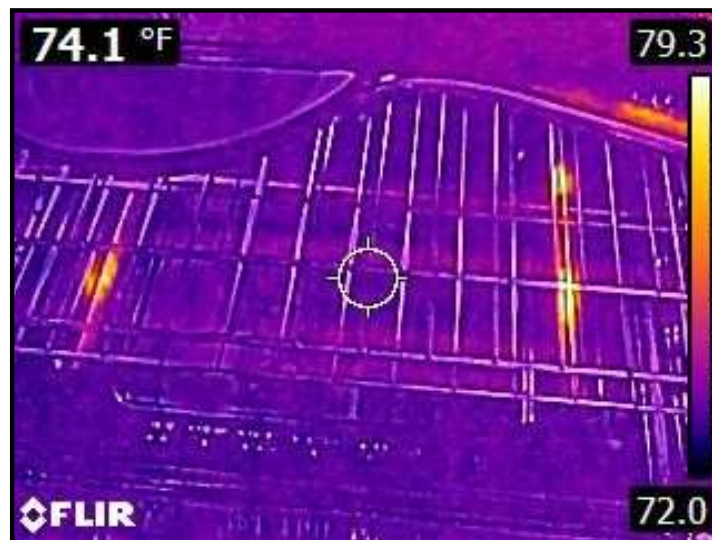
10. Oven & Range

- All heating elements operated when tested.
- Oven: gas burners

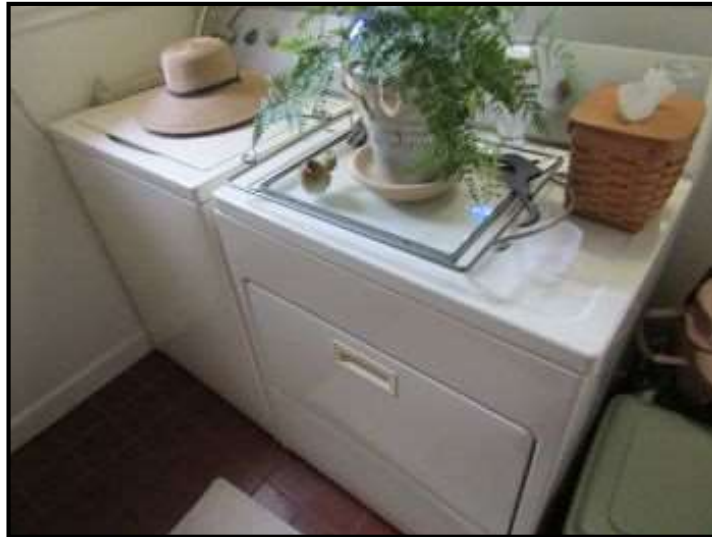
- **The washer and dryer operated properly at the time of the inspection.**
